Leakage Study of 45nm SRAM Devices with Different Layouts Using Advanced e-beam Inspection Systems

Hong Xiao, Eric Ma, Fei Wang, Yan Zhao, and Jack Jau

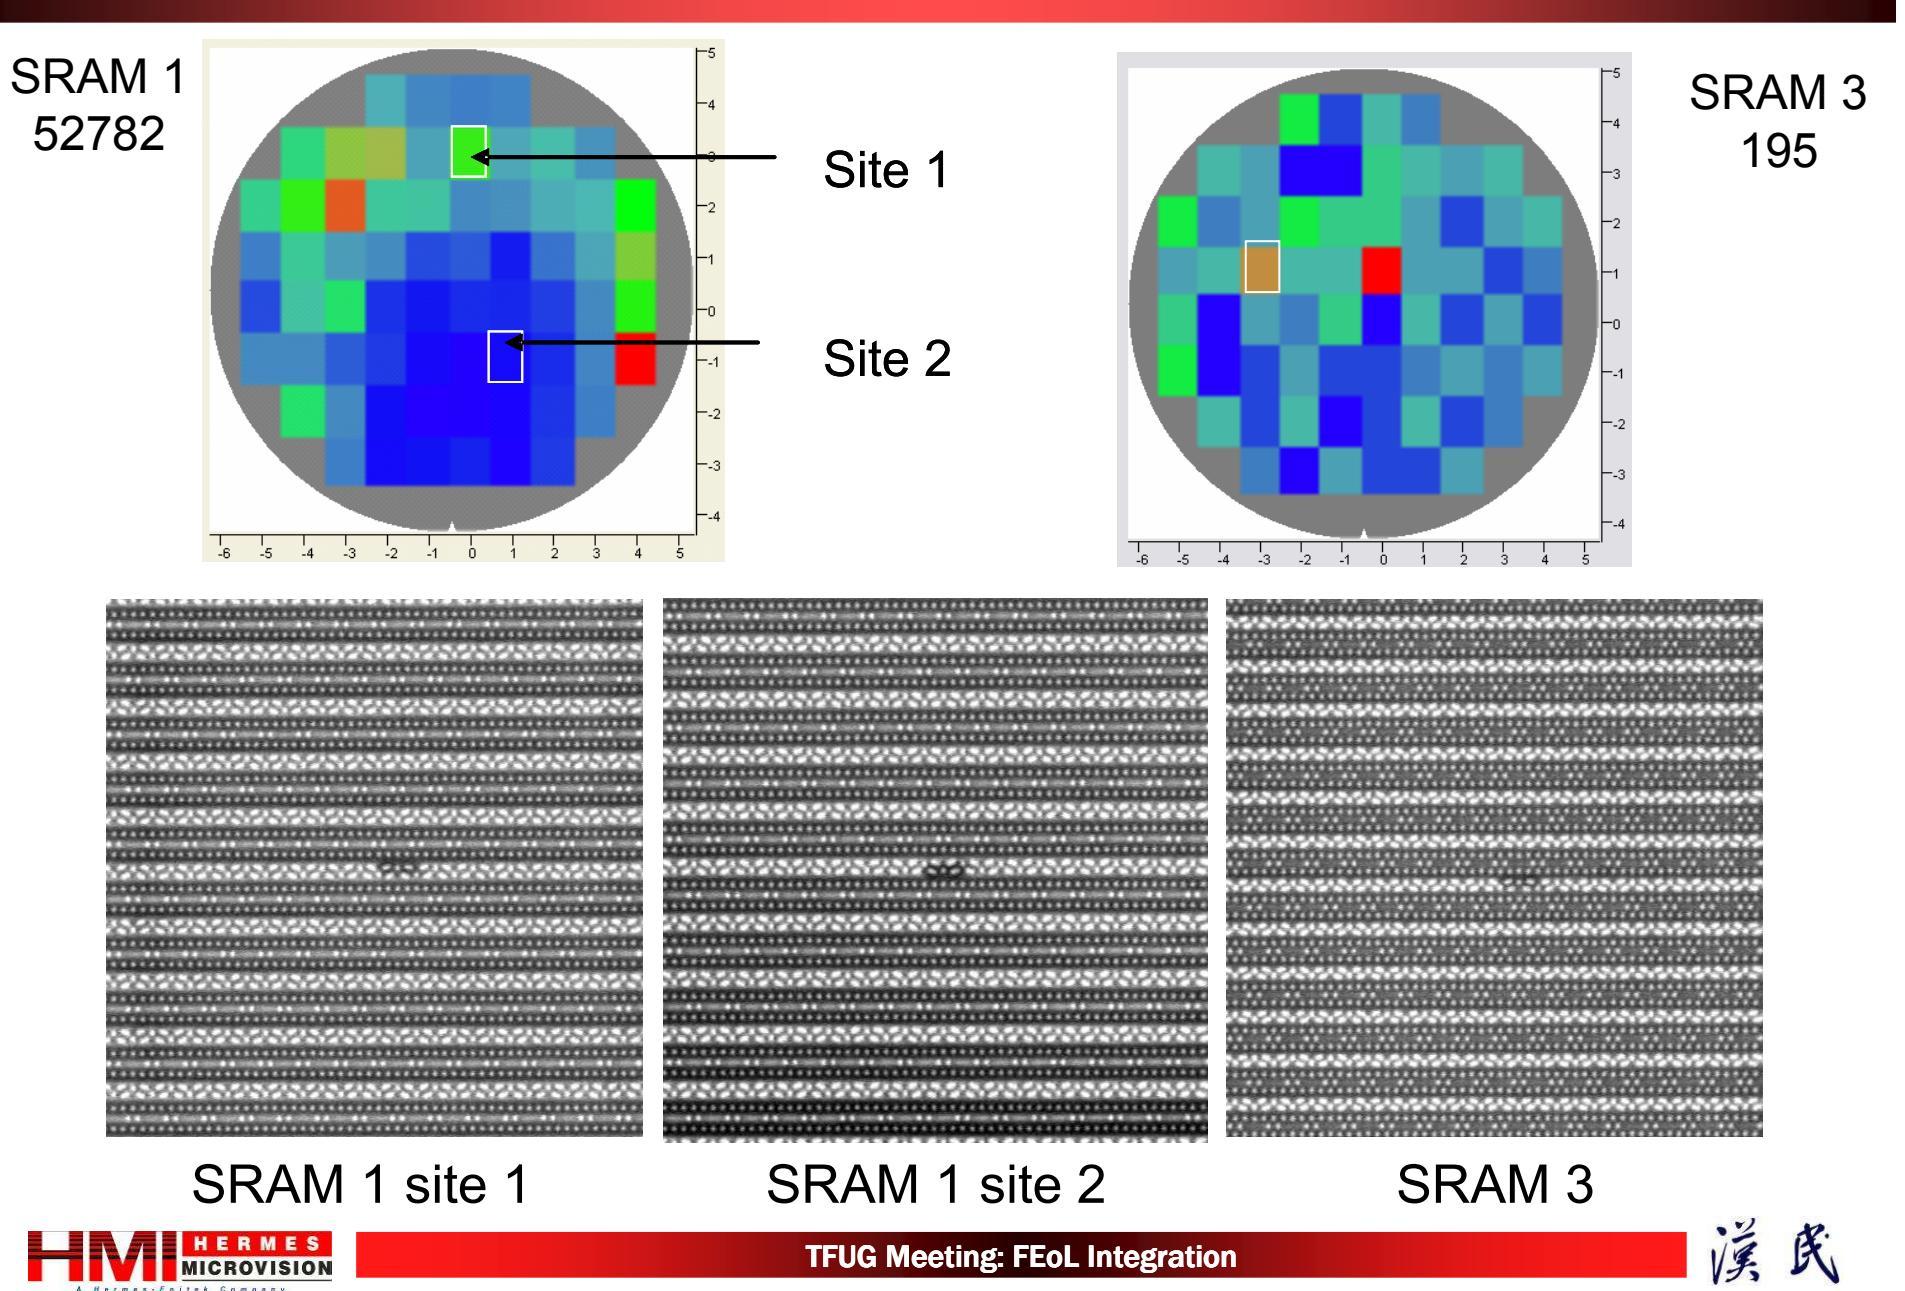
P+/N-well Leakage (WCMP DVC) Page: 12

- PMOS Leakage
 - DVC of WCMP Negative ModeTM
 - SRAM 1 & SRAM 3 have different signatures
 - SRAM 1 has "horseshoe" signature
 - SRAM 3 has random signature
 - SRAM 1 has much more PMOS leakage than that of SRAM 3.

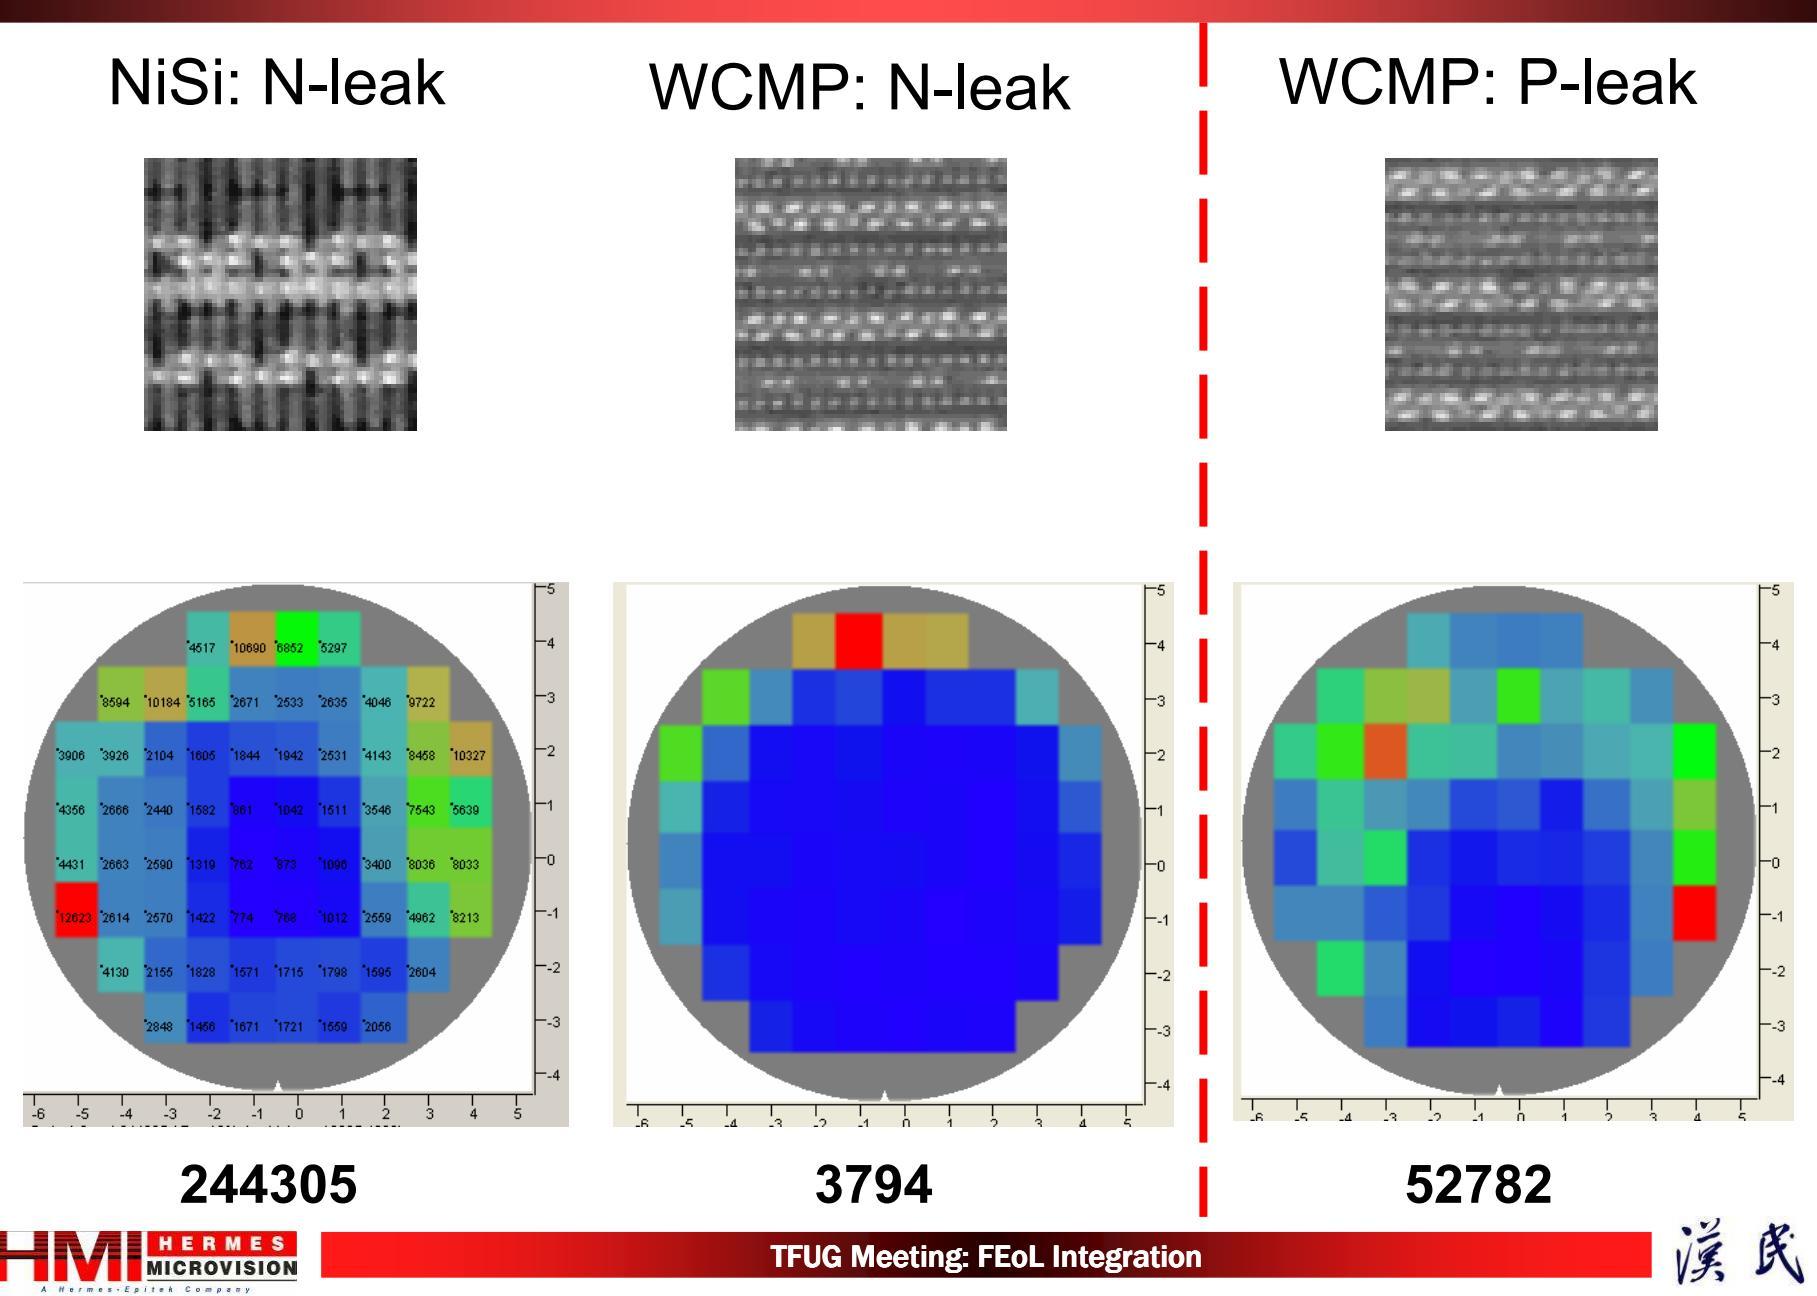
SRAM 1 Leakage

- NMOS Leakage
 - BVC of WCMP positive mode
 - DVC of WCMP Negative ModeTM
 - BVC of NiSi positive mode
- N+/P-well leakage has different signature from P+/N-well leakage signature in SRAM 1
- SRAM 1 and SRAM 3 have different N+/Pwell leakage signatures

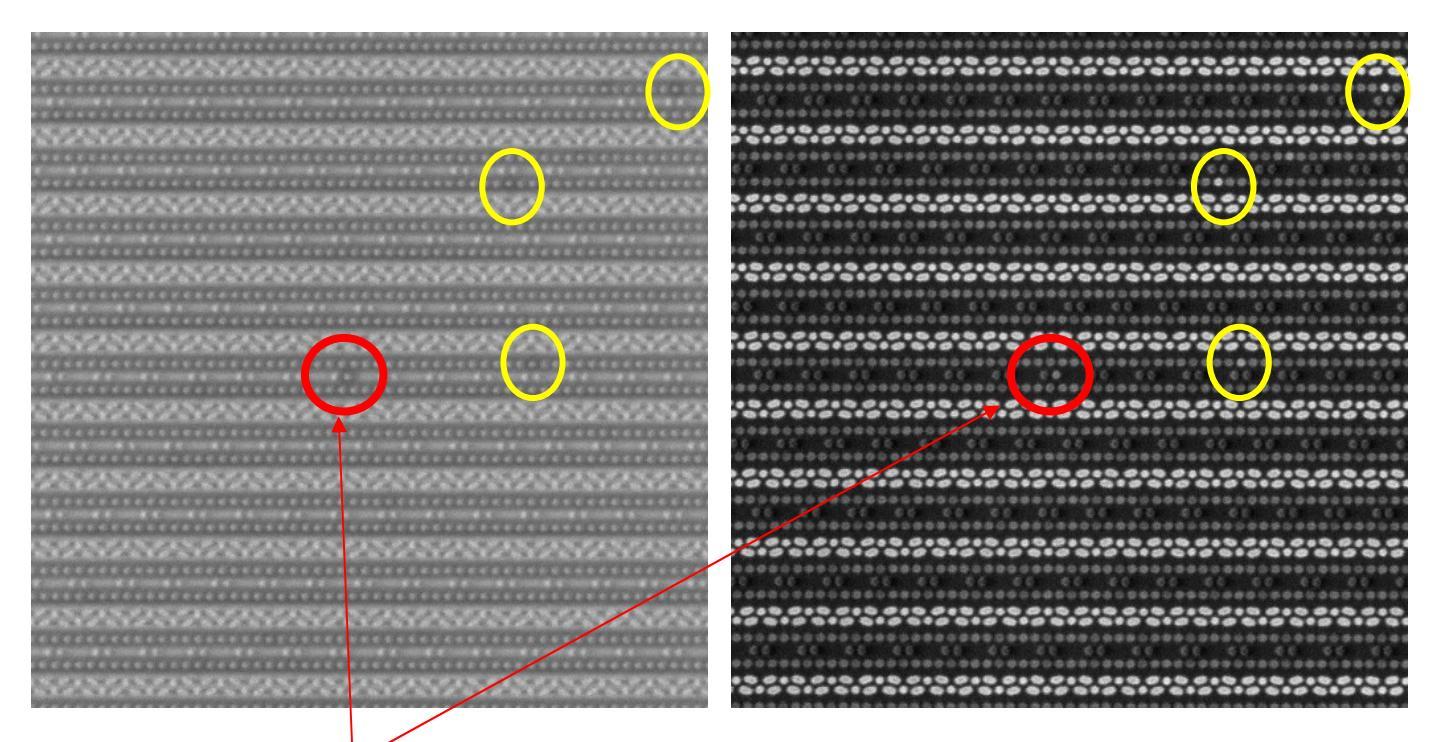
- Possible contact-to-poly short
 - Pass gate: WCMP Negative Mode[™] DVC
 - Pass gate: WCMP positive mode Weak BVC

Gate poly short to N+ contact plug

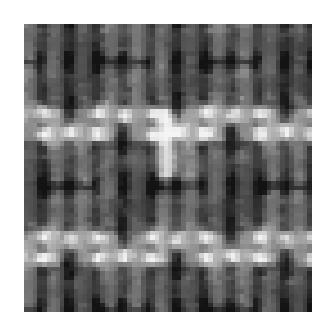
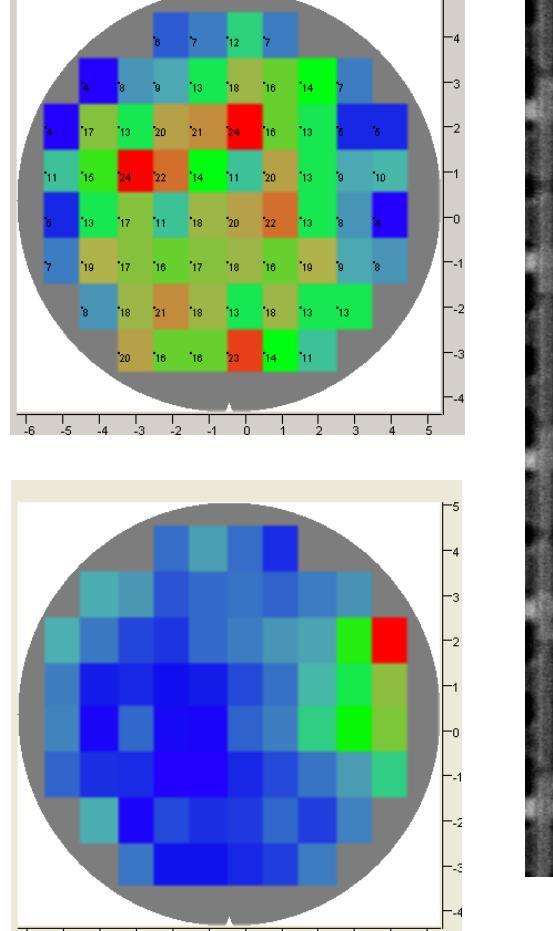
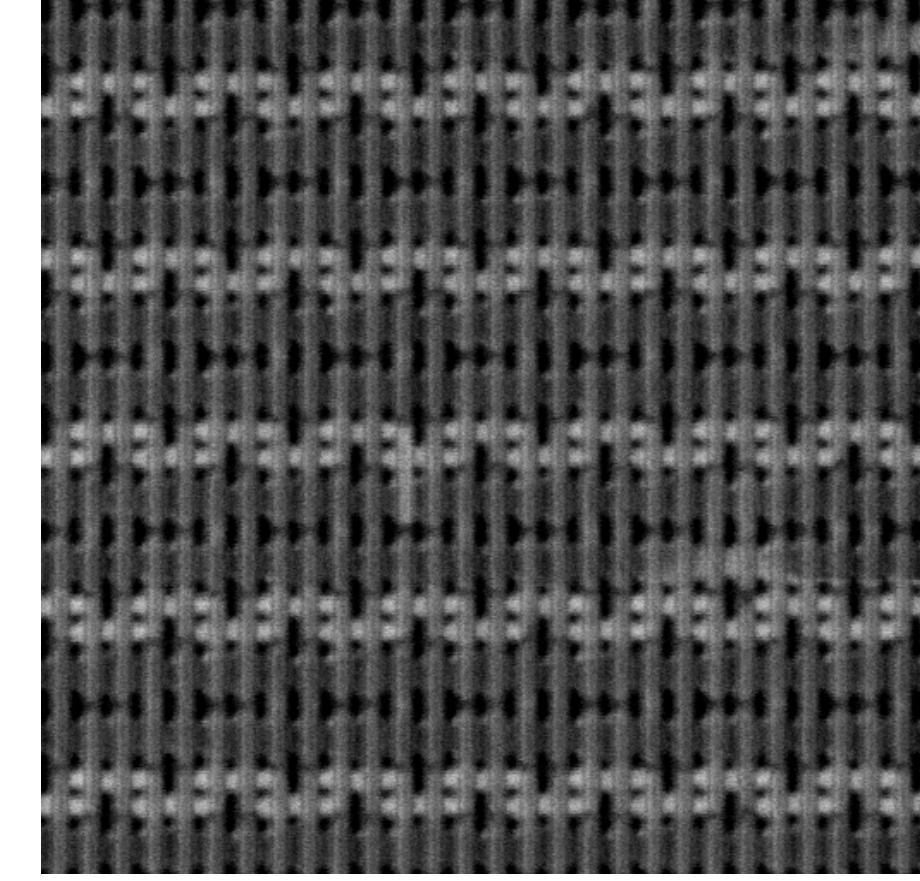
SRAM 3 16066

• Gate Leakage: NiSi gate BVC

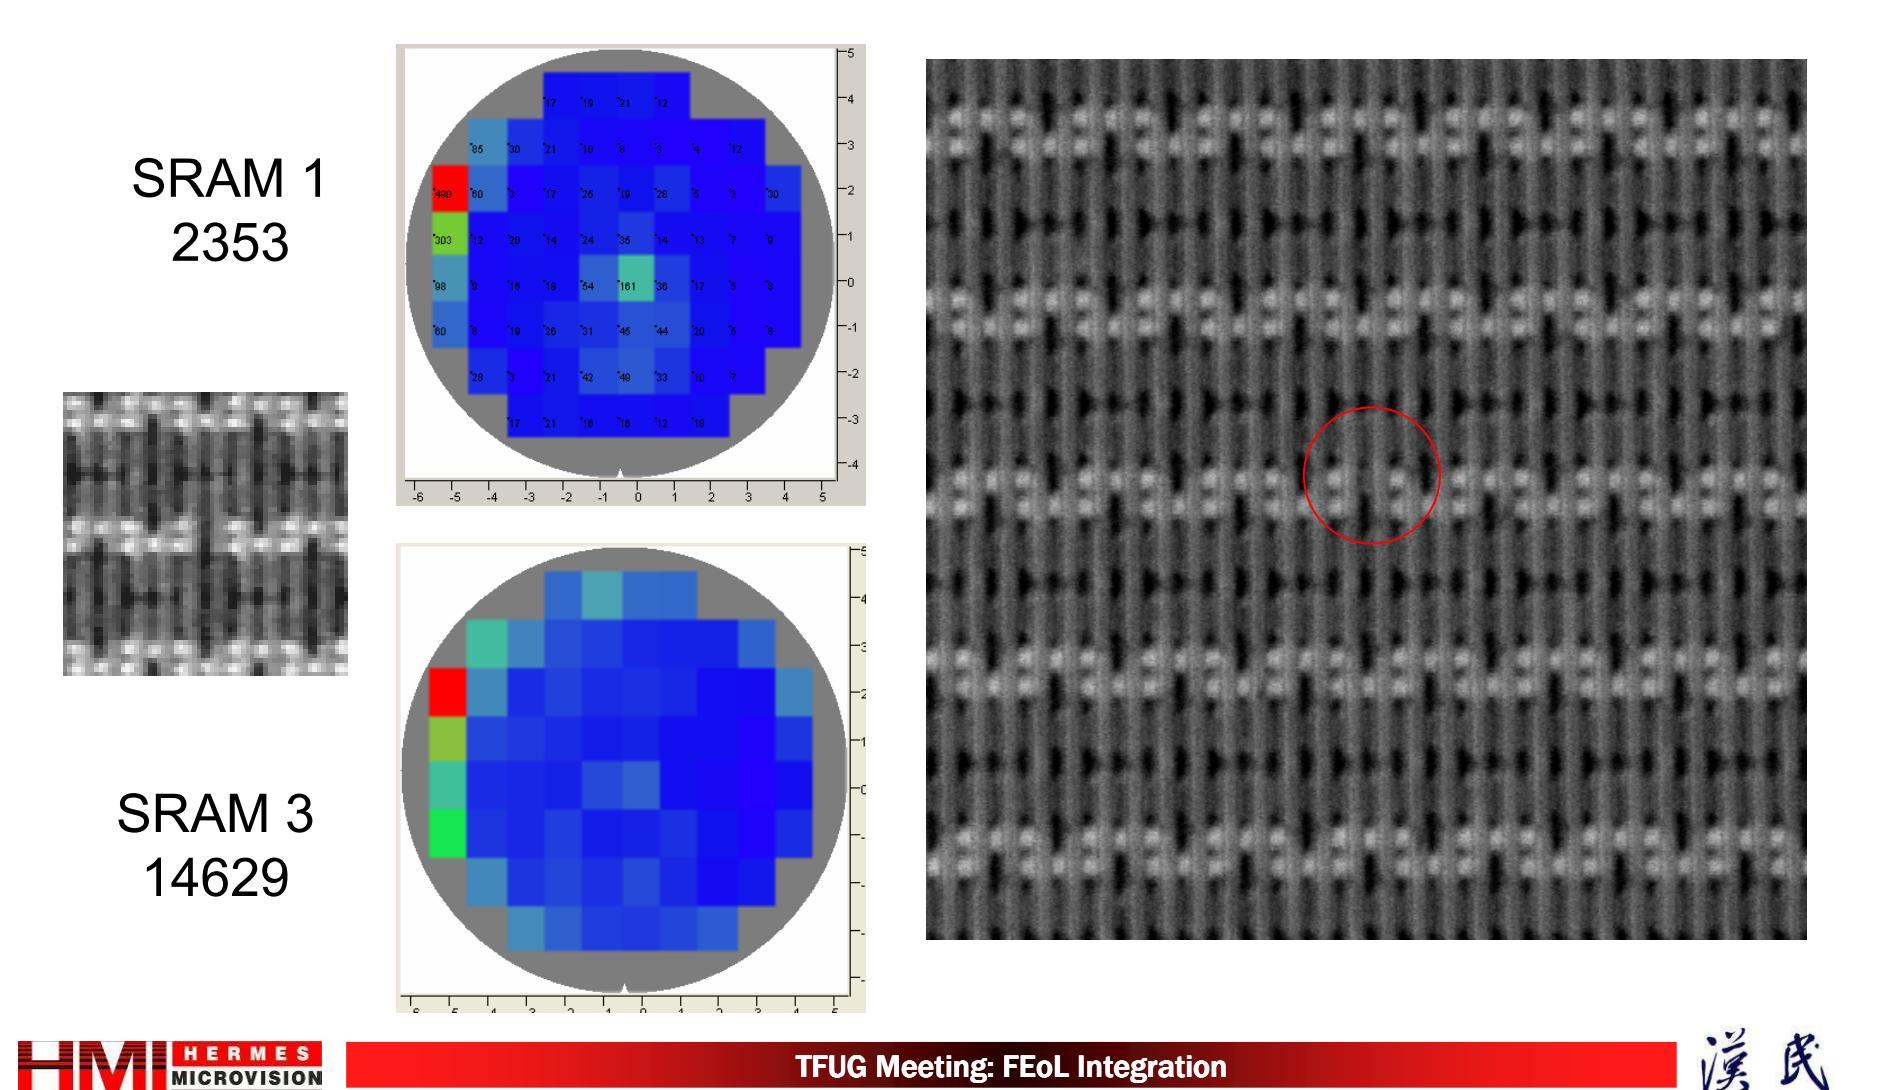
NiSi dark defect likely caused by NiSi missing

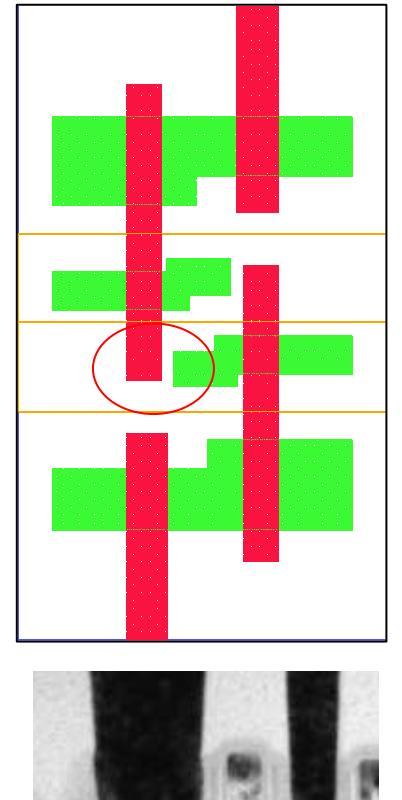
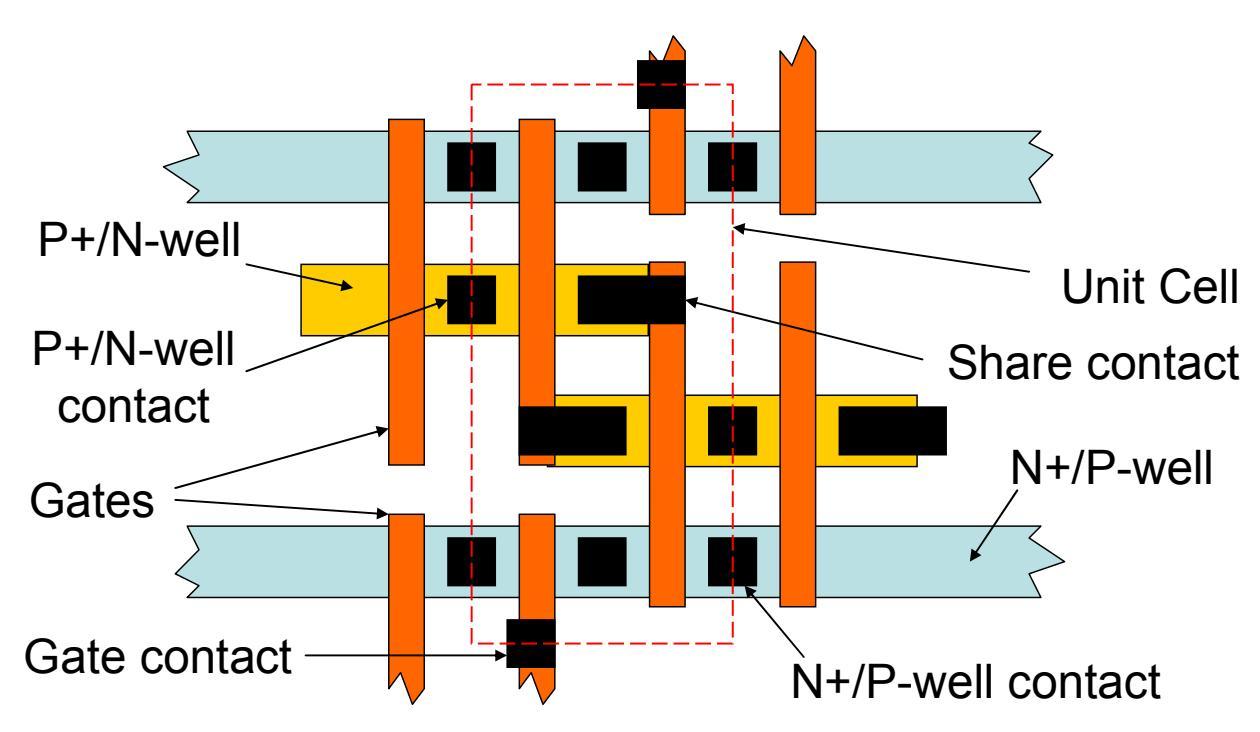
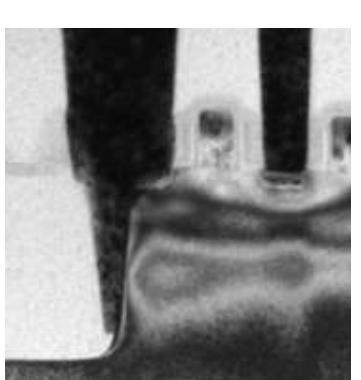
- Overlap inverter gate and N-well AA
- Avoid share contact touching STI
- Over etch can cause PMOS leakage
