Investigating Ceria-Related Defects on SiO₂ Films from Nanoparticle Remnants and Tribofilms

Van-Tuan Nguyen¹, Tomoya Nishi², Hirokuni Himaya², and Jihoon Seo¹

Ceria Defect is the Main Defect in STI-CMP with Ceria-based Slurry

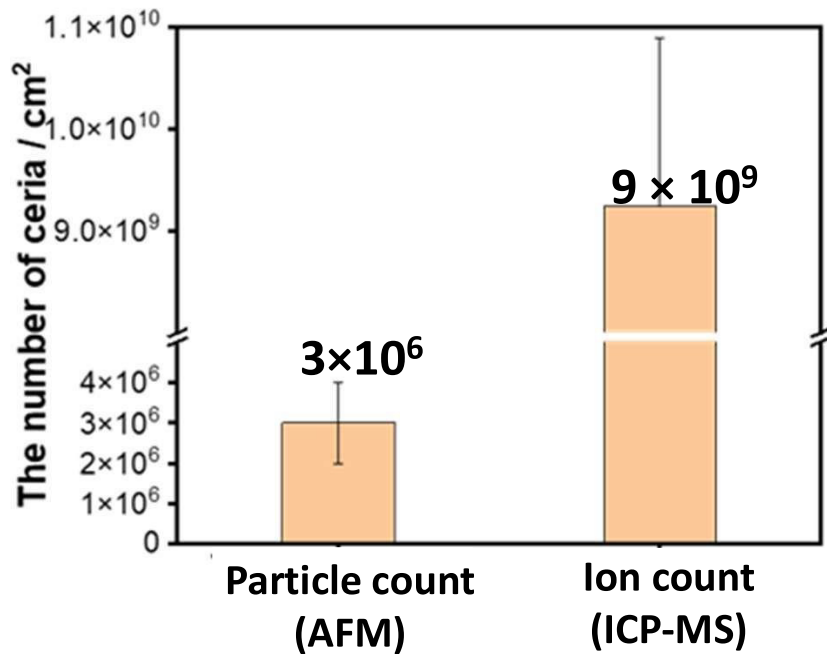
The Results of Particle Count and Ion Count

The density of Ceria defects on the film estimated from Ion Count is higher than Particle count **3000 times**.

→ This gap suggests the presence of Ceria-related Defects.

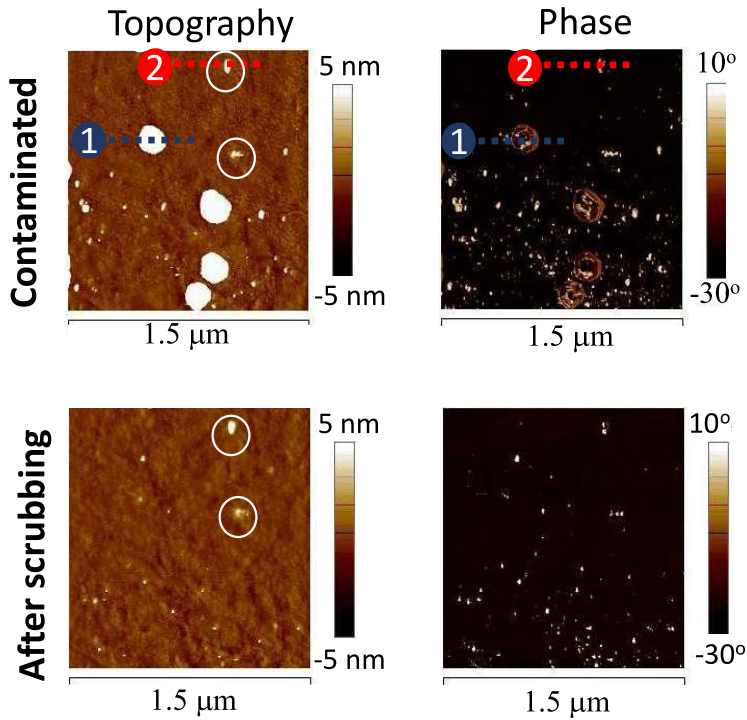
There is the Presence of Small Ceria with the Size of 10 – 15 nm

Small particles persist on the film after cleaning.

There are Ceria fragment on the film with the size of 10 -15 nm.

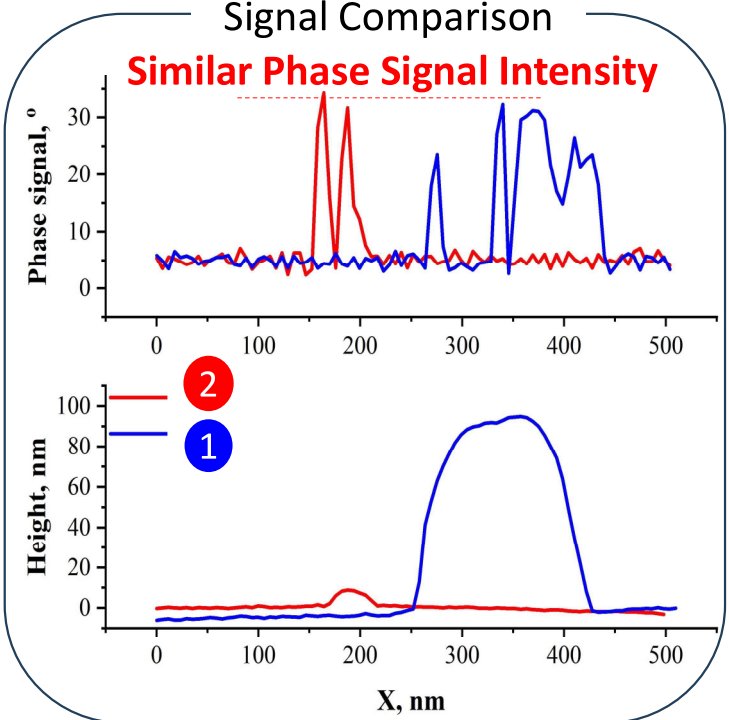
Phase Signal confirm small particles are Ceria.

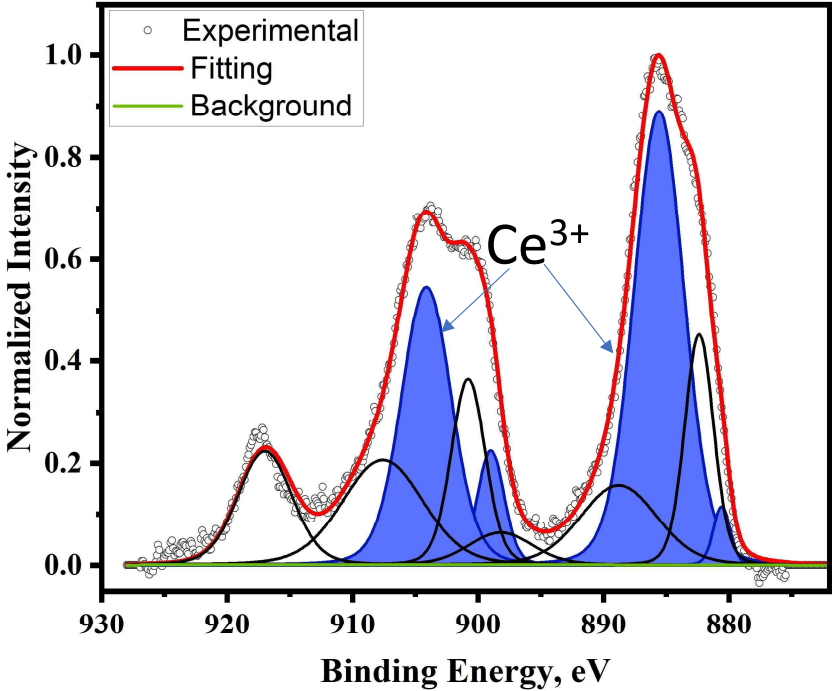
Chemistry Analysis of Ceria Defects

The main state of Cerium in the Ceria defects is **Ce³⁺ (56.5%)**, much higher than the **Ce³⁺ from the Ceria abrasive defects (28%)**.

It can be due to the **small fragments (Case b)** and **Tribofilm (Case c)**.
