Analyses of Diamond Disc Substrate Wear and Diamond Micro-Wear in Copper Chemical Mechanical Planarization Process

**Y. Zhuang ^{1,2}, A. Meled ¹, X. Wei ¹, J. Cheng ¹, Y. Sampurno ¹,
L. Borucki ², A. Philipossian ^{1,2}, M. Moinpour ³, D. Hooper ³**

¹ University of Arizona, Tucson, AZ 85721, USA

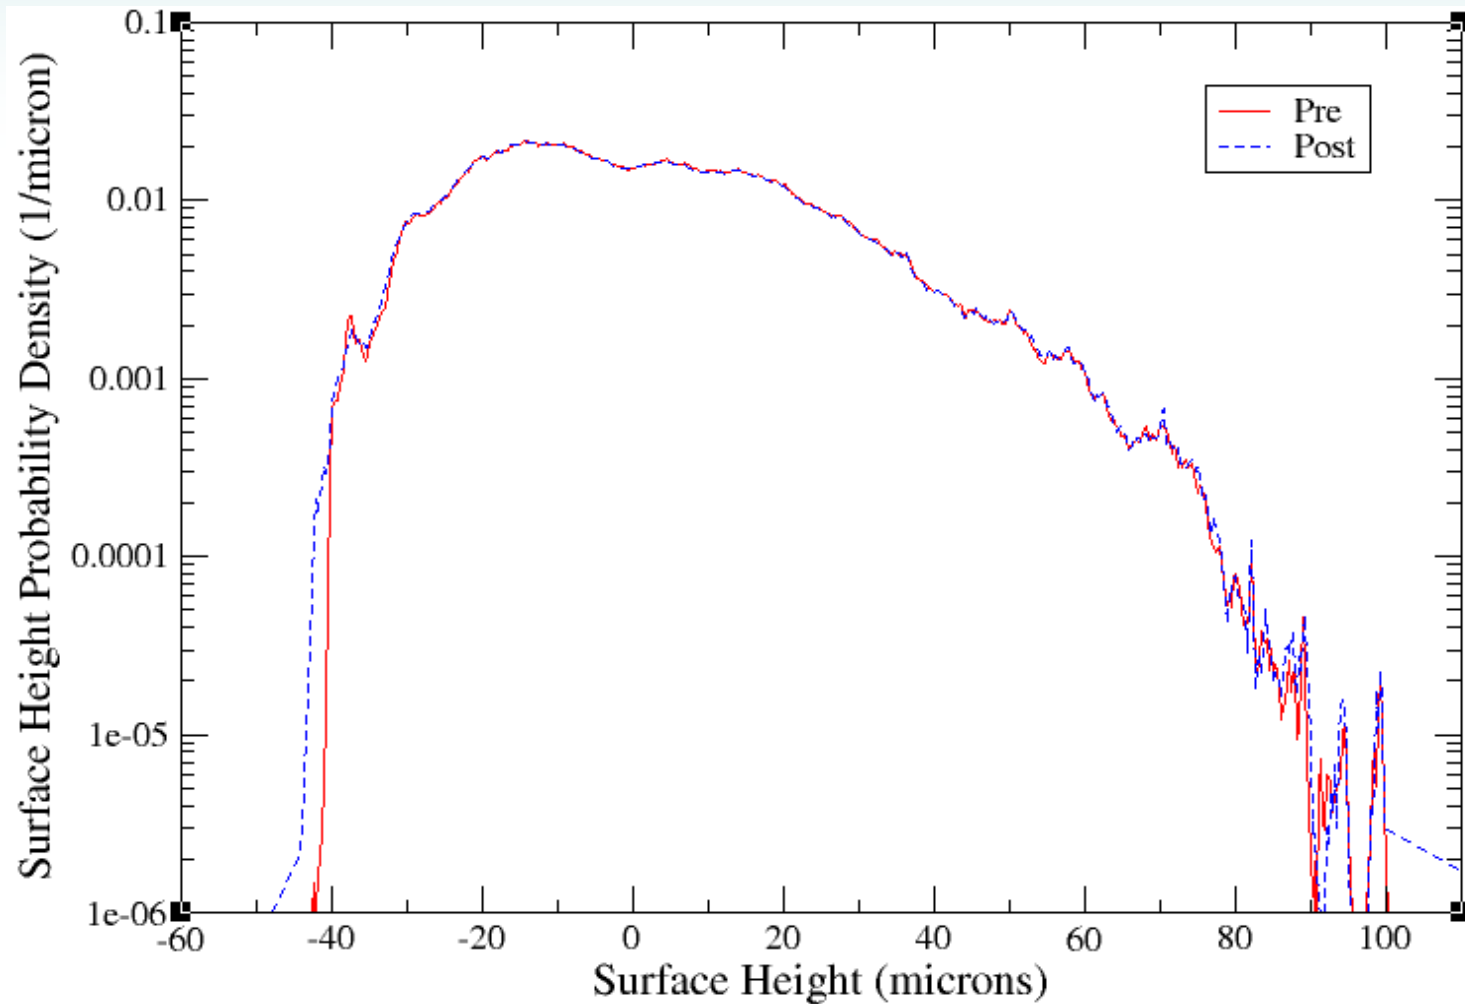
Diamond Disc Surface Height PDFs

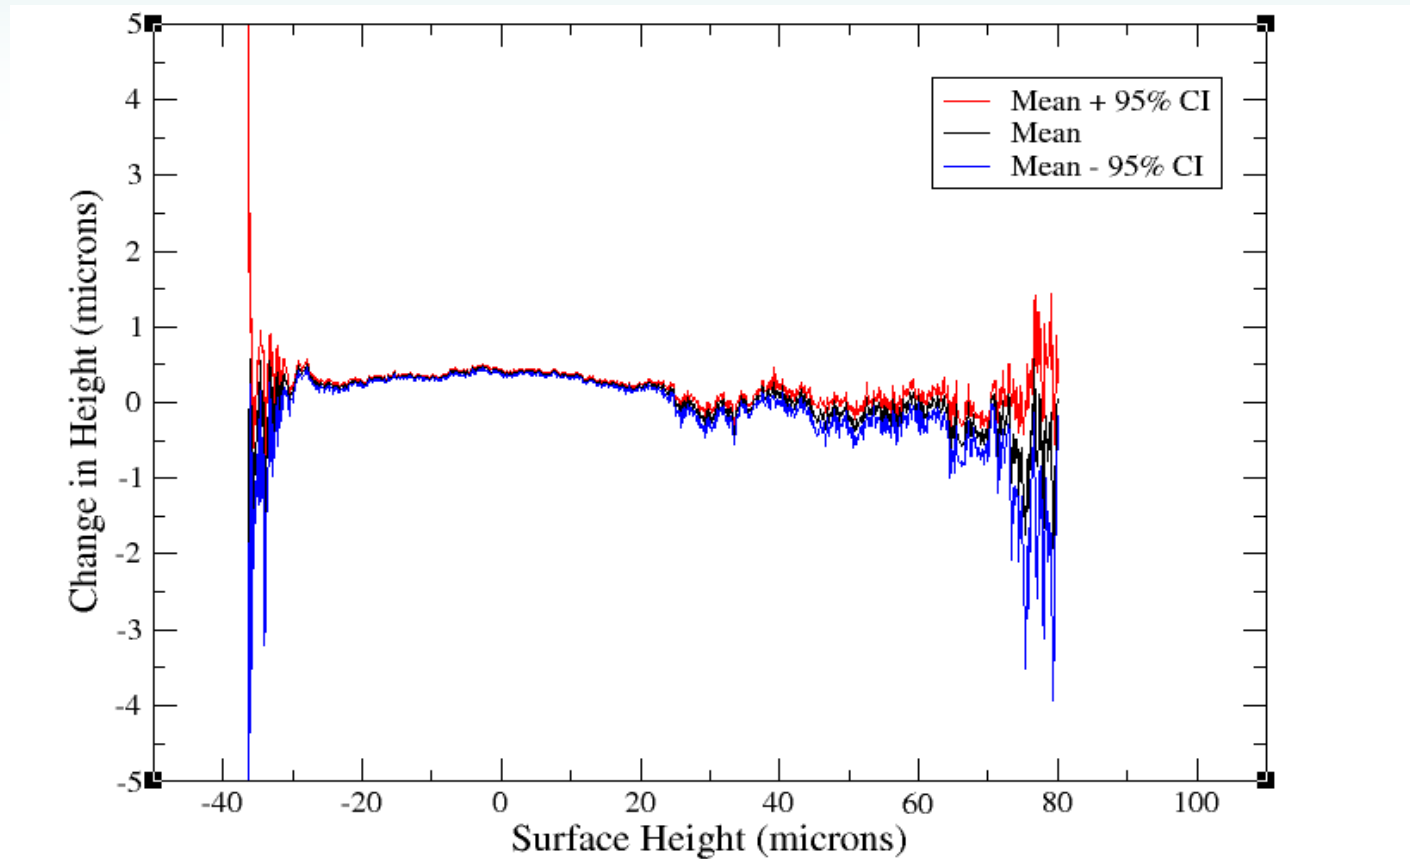
Change in Diamond Disc Surface Height

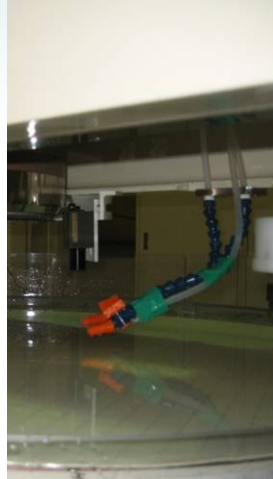
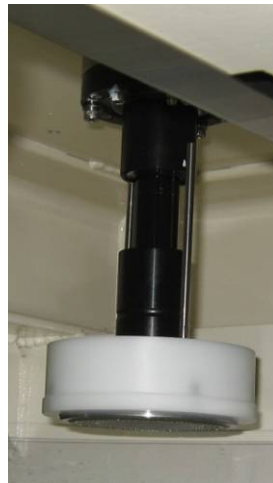
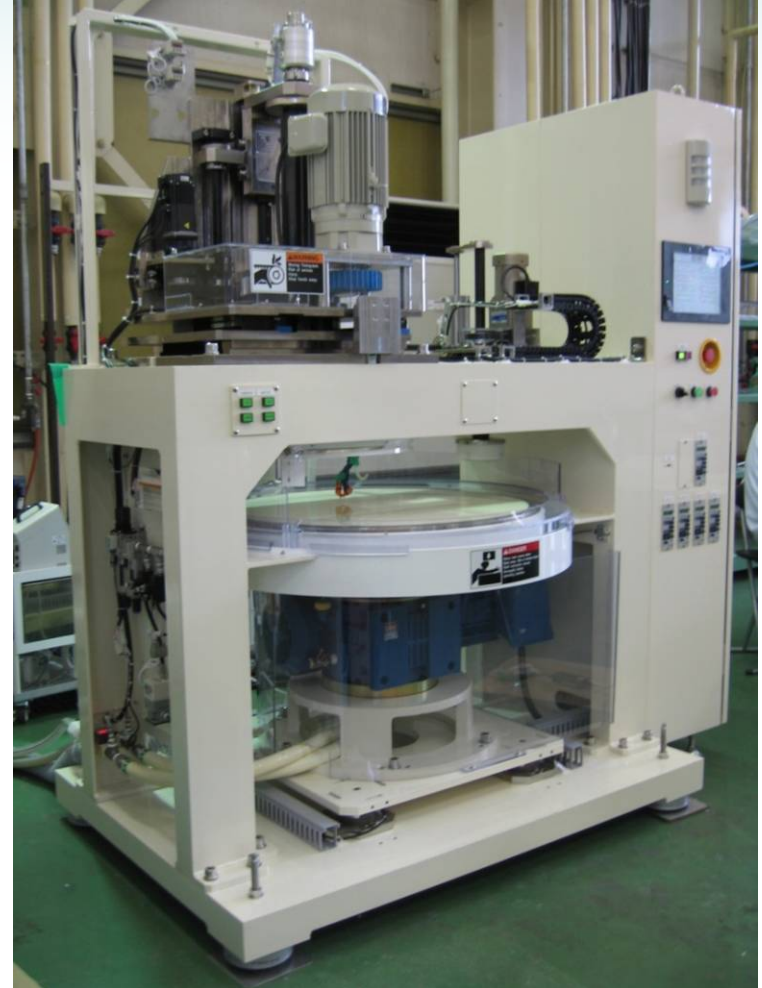
Araca APD – 800 Polisher & Tribometer
