Mechanical Stresses and Reliability Study of Cu Through-Silicon Via (TSV) Samples Fabricated by SK Hynix vs. SEMATECH using Synchrotron X-Ray Microdiffraction for 3-D Integration and Reliability

A.S. Budiman^{1*}, H.-A. Shin², B.-J. Kim², S.-H. Hwang², H.-Y. Son³, M.-S. Suh³, Q.-H. Chung³, K.-Y. Byun³, Y.-C. Joo², R. Caramto⁴, L. Smith⁴, M. Kunz⁵, N. Tamura⁵

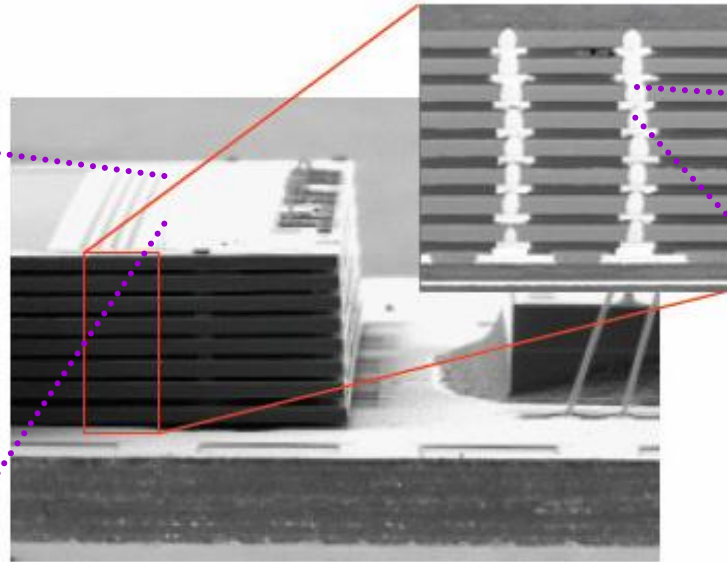
❖ Si stress

Keep-away zone

Device must be kept away from the zone in which mobility is changed.

Si cracking

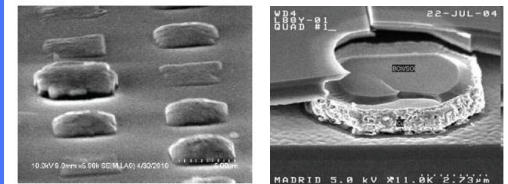
❖ Cu stress

Debonding, TSV cracking

TSV Pop-up, Bulging-up → Integration Issues

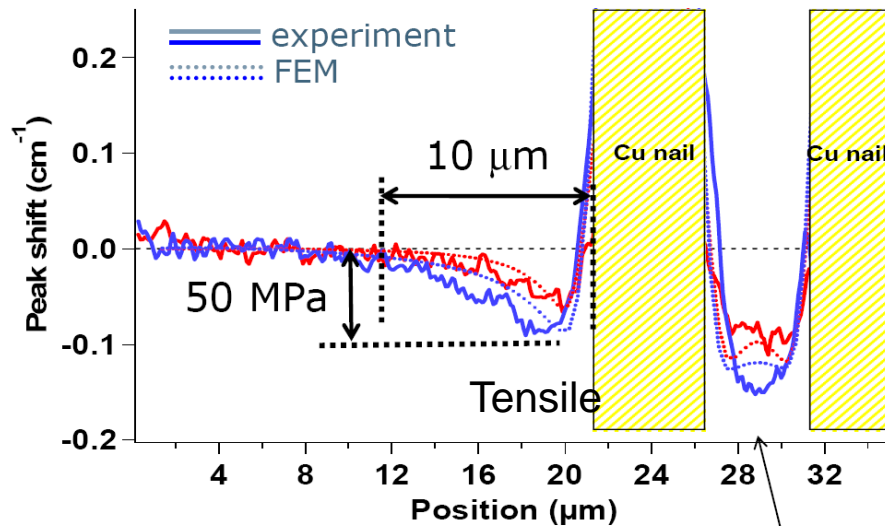
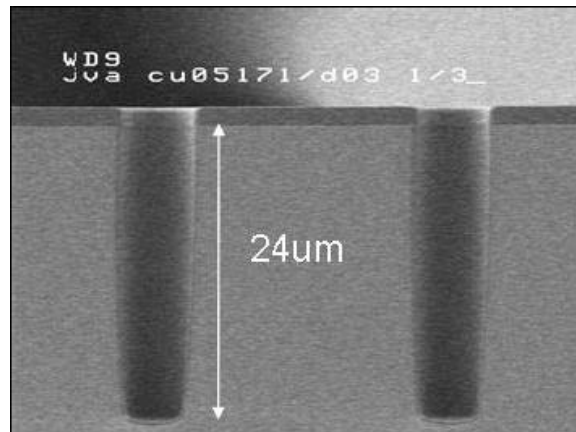
Stress of Si : μ -Raman spectroscopy

Diameter 5 μm ,
pitch 10 μm ,
depth 24 μm

- TSV-induced stress extends about 10 μm in Si
- 50 MPa **tensile stress in Si** after cycling

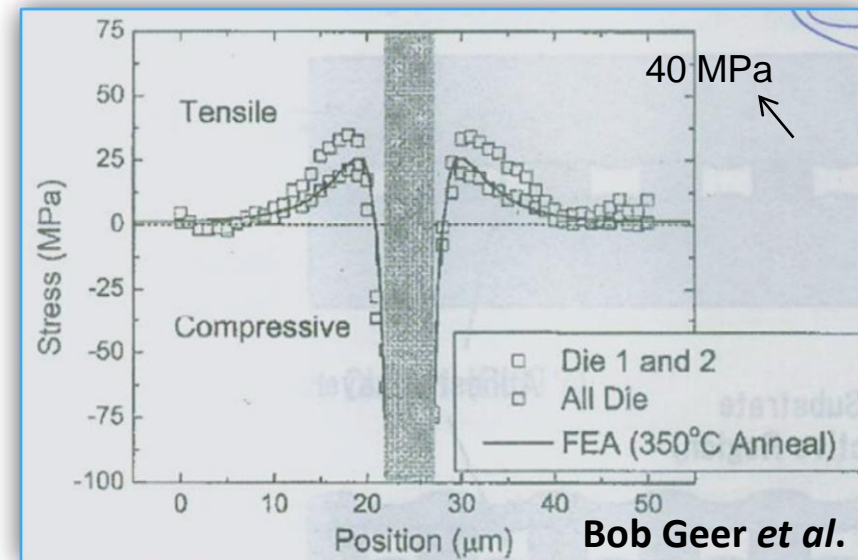
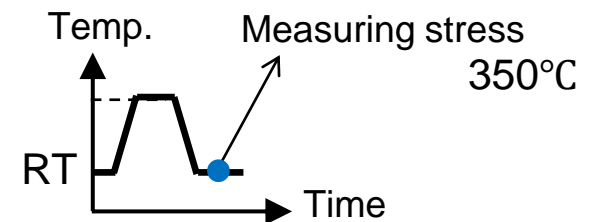
- 40 MPa **tensile stress in Si** was developed near Cu TSV after cycling.

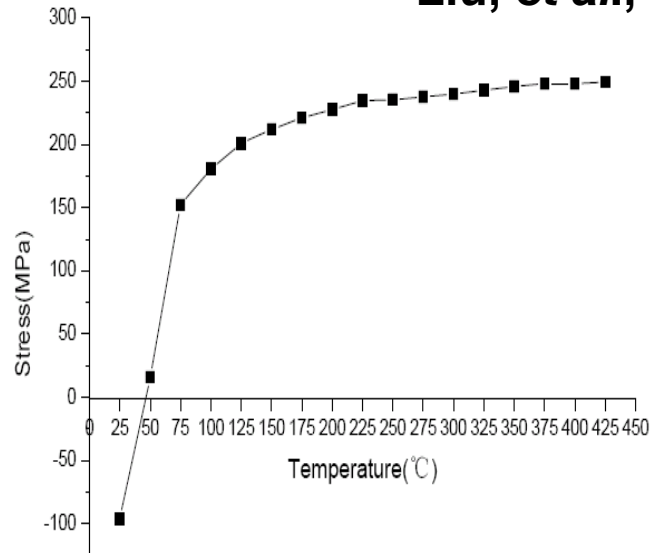
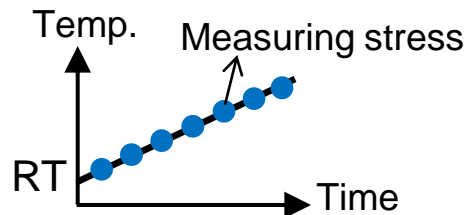
Stress of Cu : Laboratory XRD

Lack of micron resolution

Diameter 70 μm , pitch
140 μm , depth 460 μm

- + 225 MPa at 200 °C.
- - 100 MPa at 25 °C.

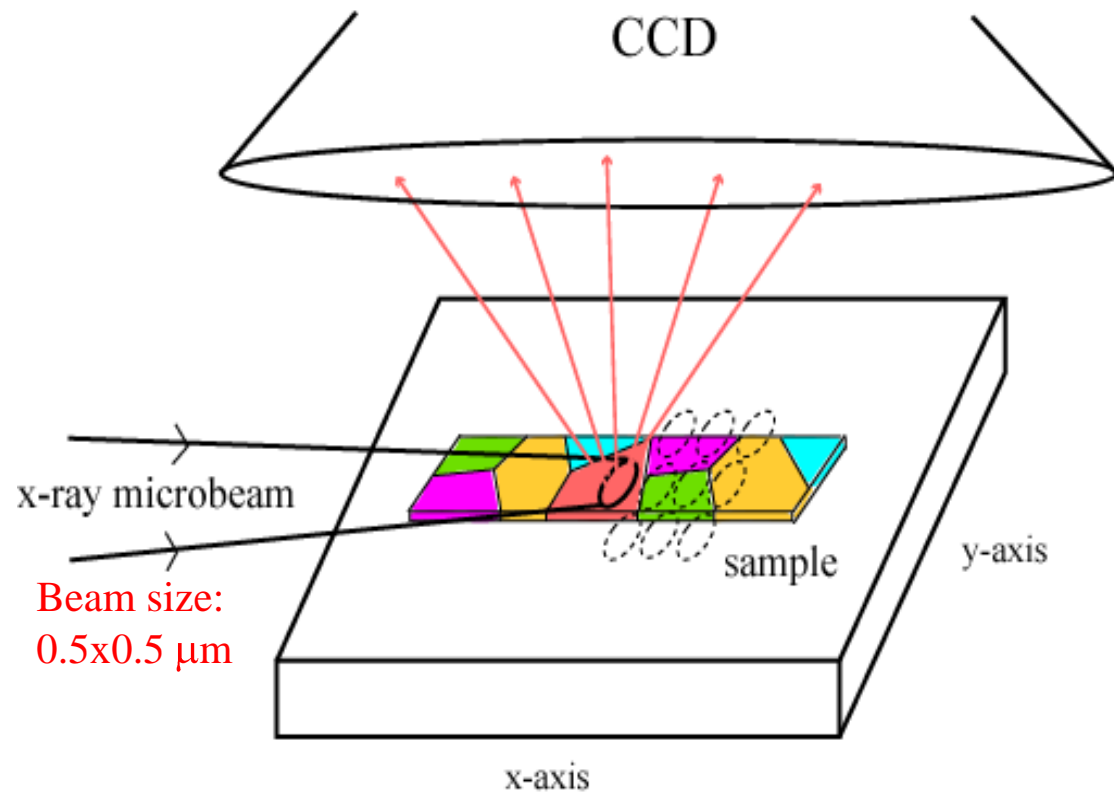
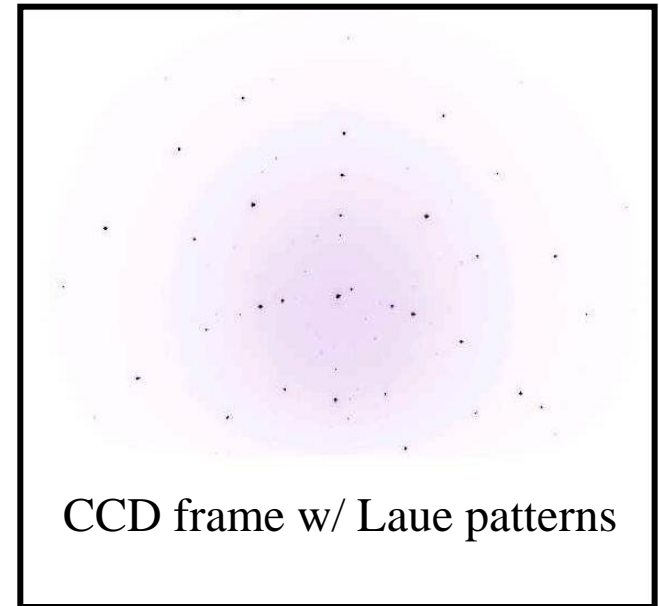
Synchrotron X-Ray Sub-micron Diffraction

X-ray source: ALS Synchrotron,
Berkeley Lab (Beamline 12.3.2)

Deviatoric strain tensor: Small shifts in spot relative positions \rightarrow Crystal deformation at constant volume ($\sim 1 \times 10^{-4}$ accuracy)

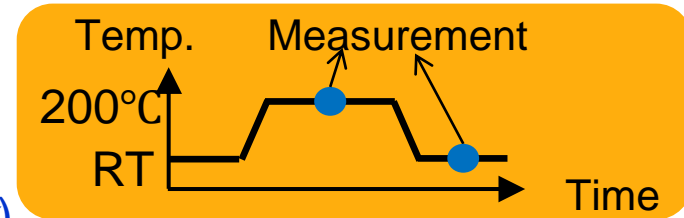
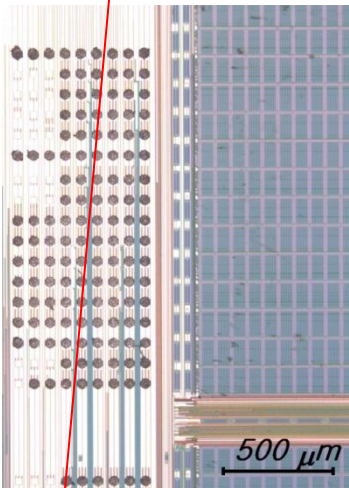
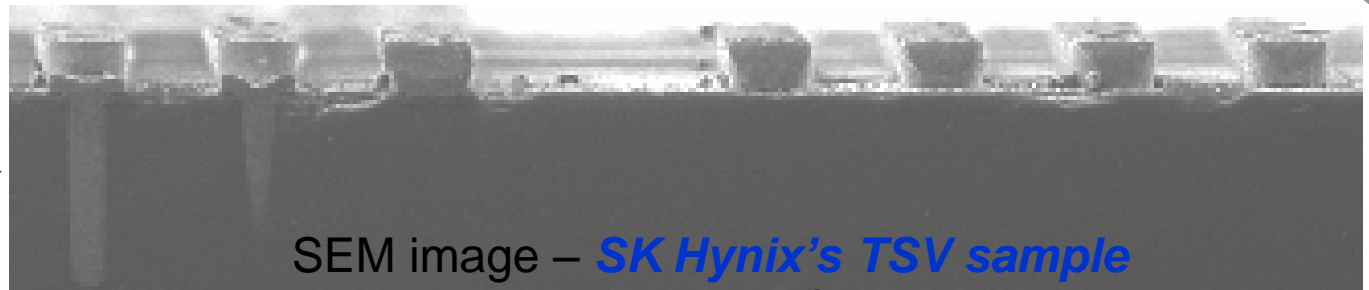
Polished with angle

Cu stress within this area

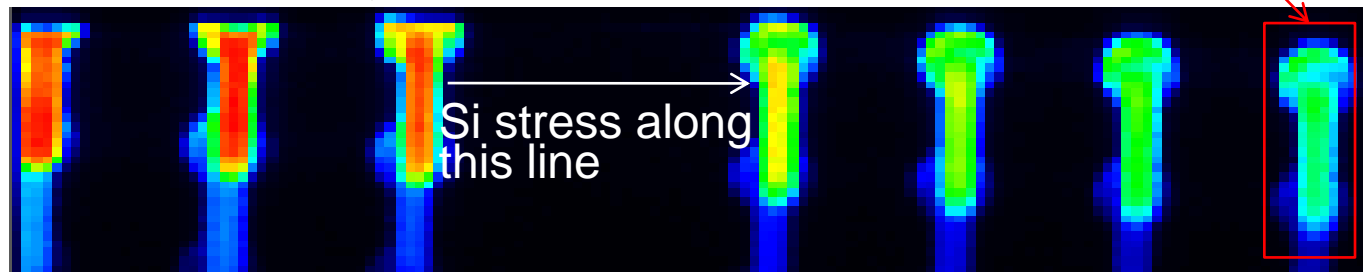
Top view of TSV array

XRF (from characteristic x-rays) image of TSV array

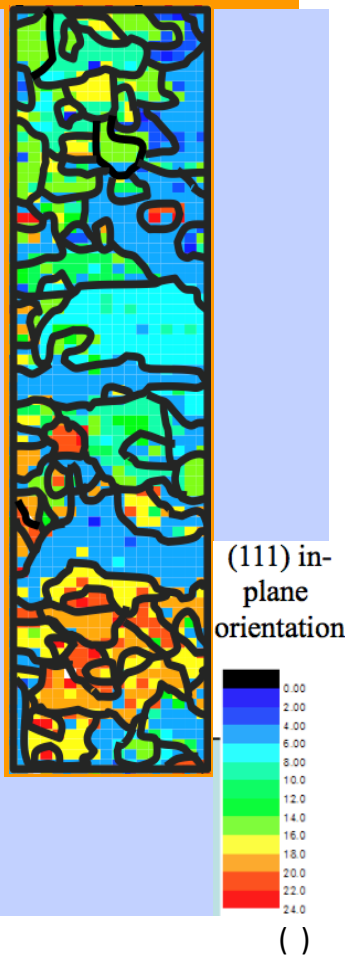
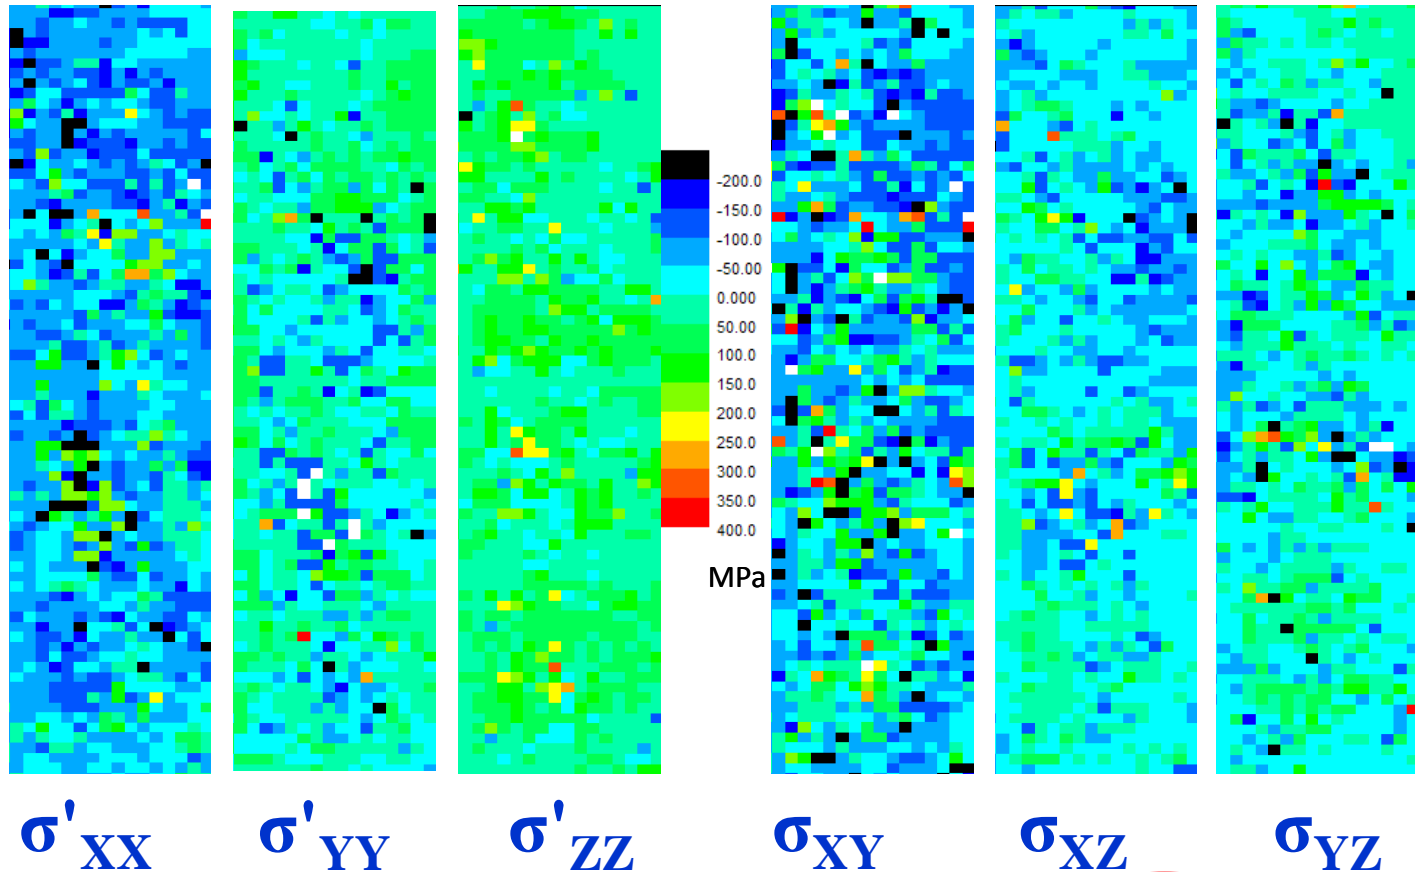
Cu Stress State in TSV – *SK Hynix*

- Post Annealed Sample (measure at RT)

Only deviatoric components of stress

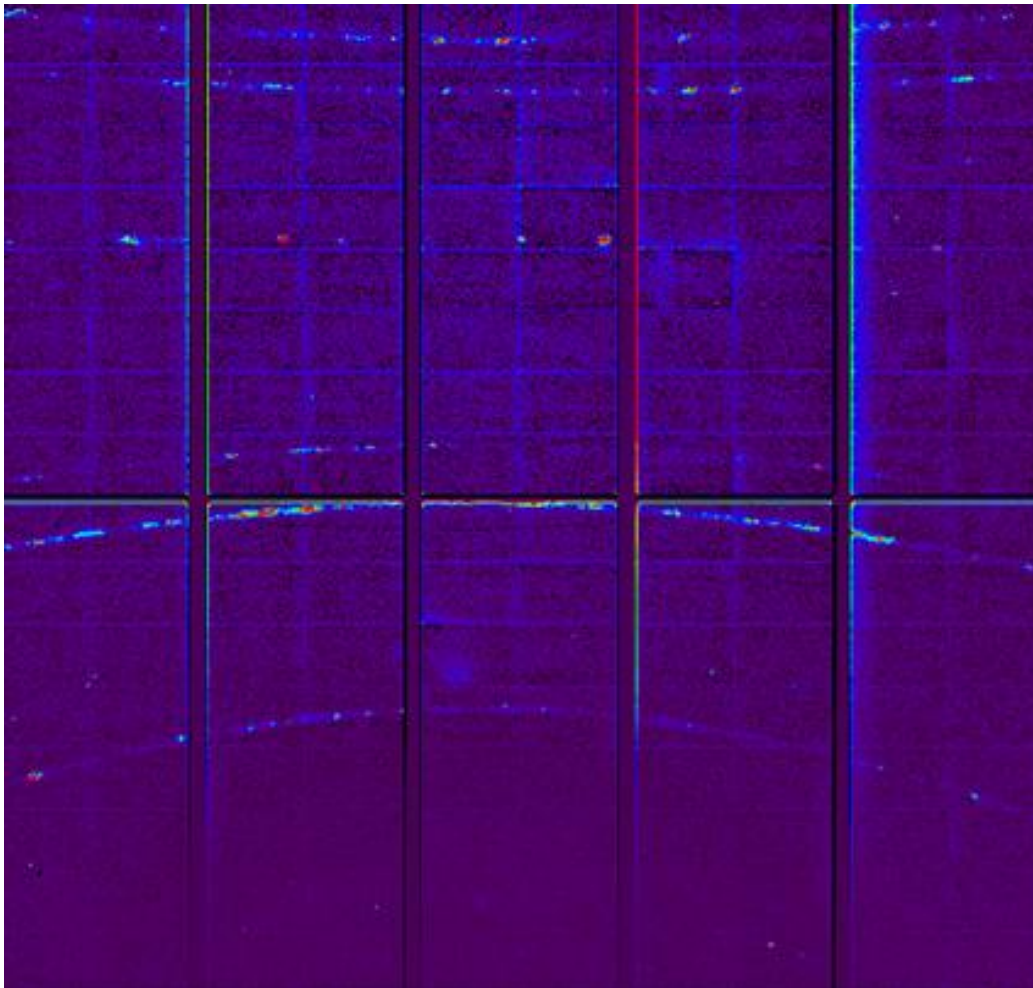
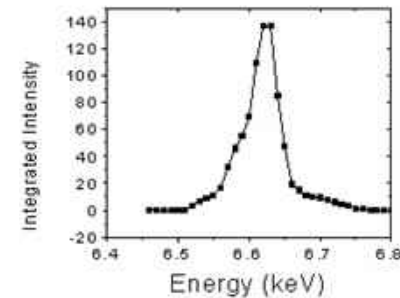
Cu Hydrostatic Stress State in TSV – *SK Hynix*

**Hydrostatic stress =
+166.6 MPa**

❖ Hydro + deviatoric

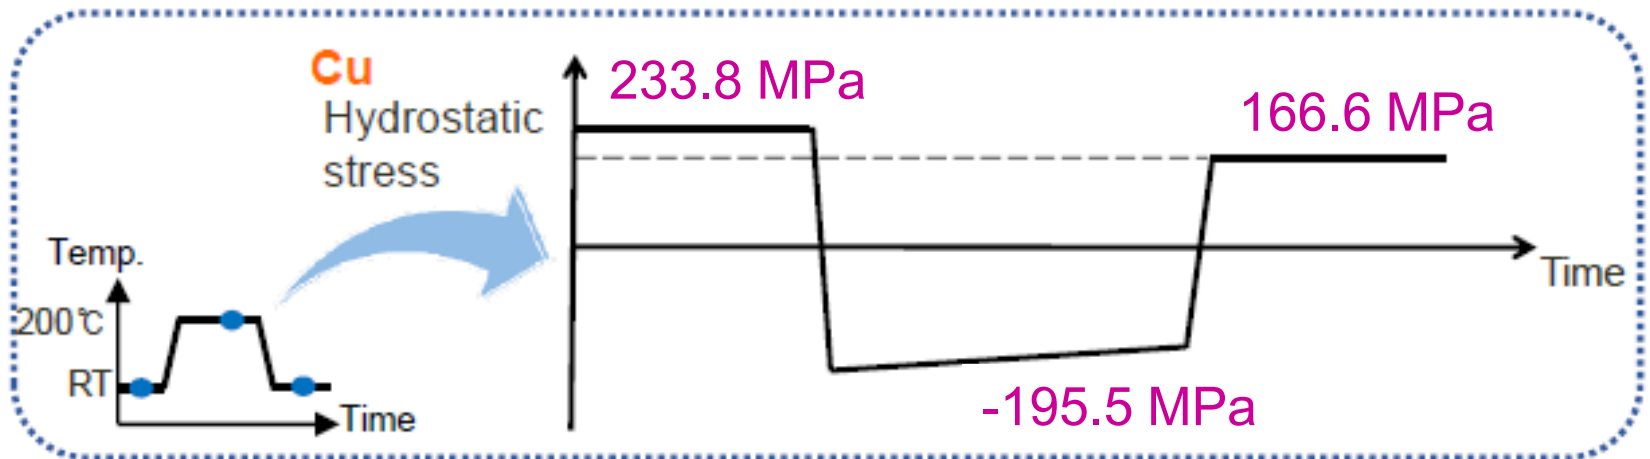
Stress Evolution in Cu TSV – *SK Hynix*

Cu hydrostatic stress

233.8 MPa

-195.5 MPa

166.6 MPa

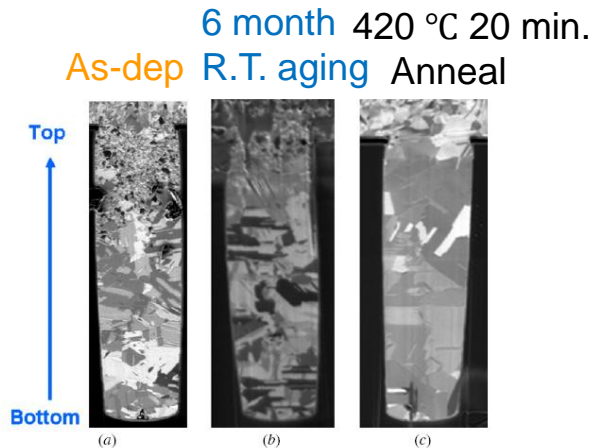
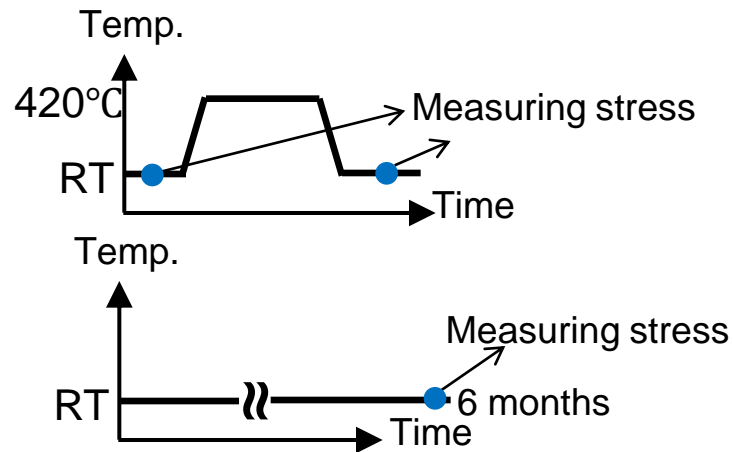
High Tensile in As-Received → Cu RT Grain Growth

- Decreasing hardness → Cu stress toward **more tensile** stress after annealing and R. T. aging.

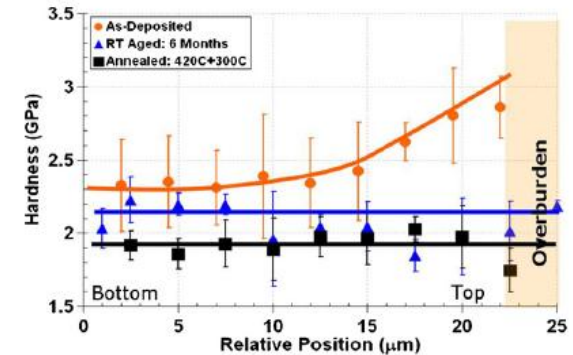
- Hardness change by annealing

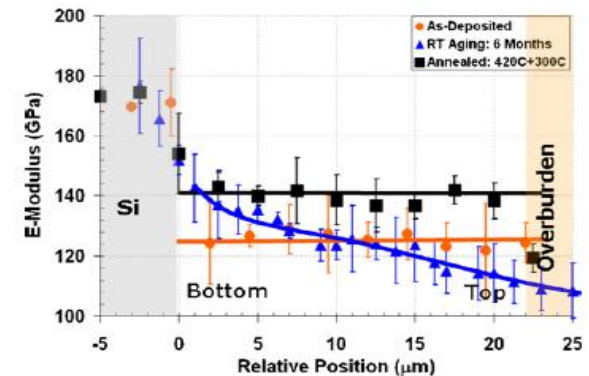
- Elastic modulus

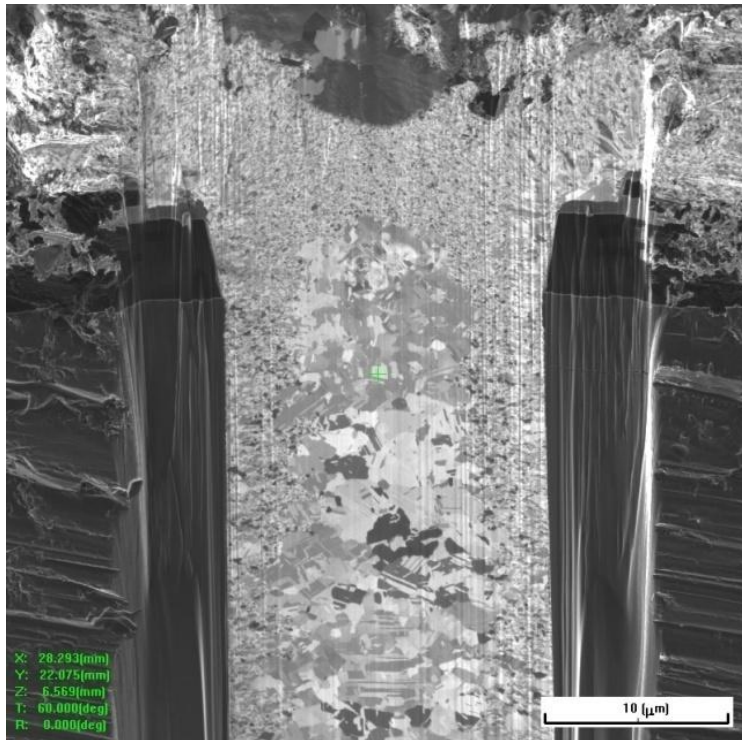
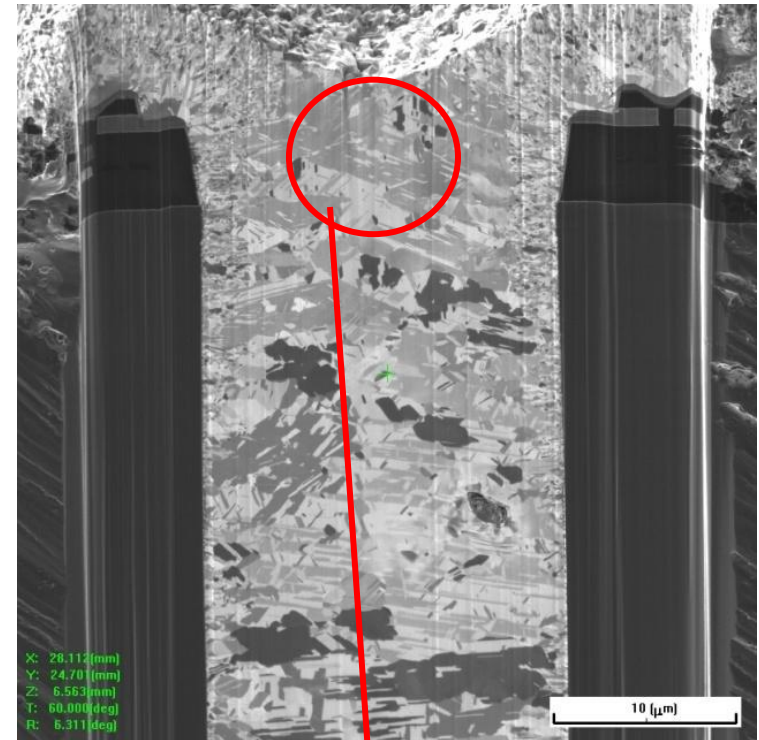
Microstructure change of Cu during annealing leads to tensile stress – SK Hynix

As received

Grain growth

200°C 1hr annealing

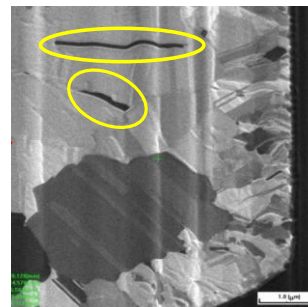
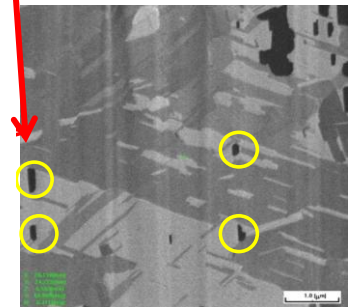
Crack

Void

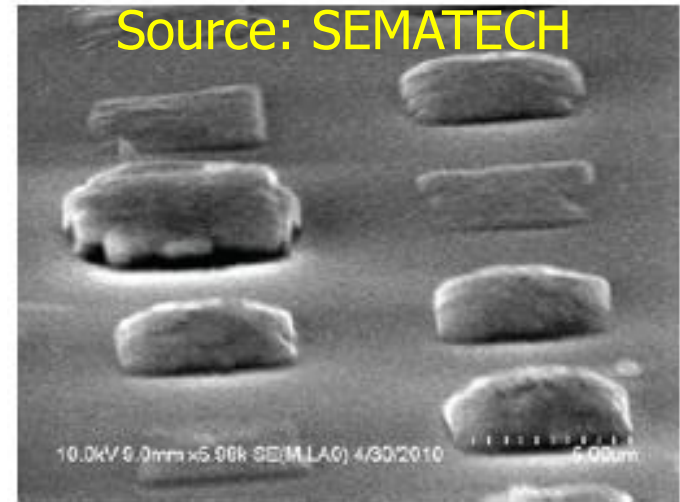
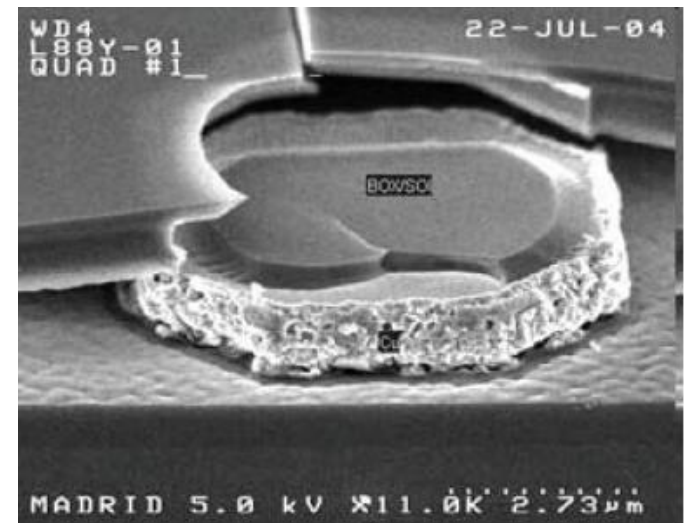
Cu TSV Protrusions:

- Popping out, bulging out during high-temp processing steps
- Cracking/flaking of dielectrics over Cu TSV and open vias to above metallization lines

Copper expansion can fracture the oxide layer above. (Source: Tezzaron)

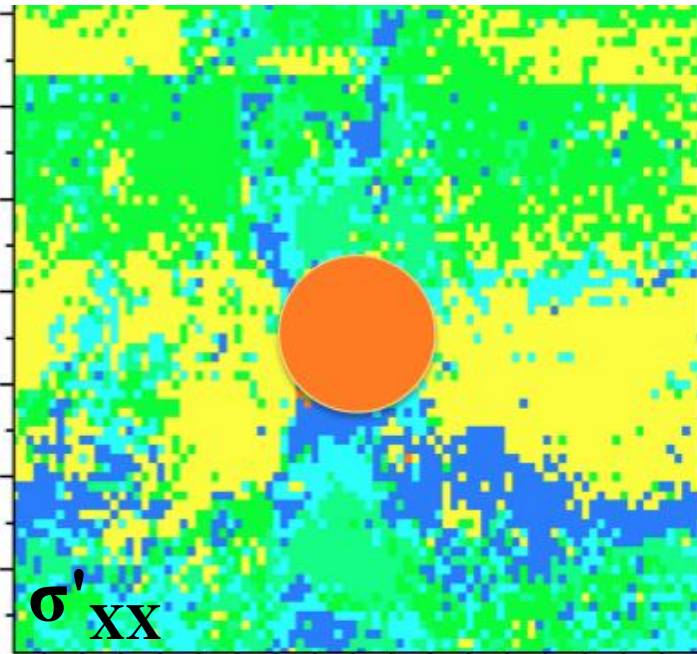
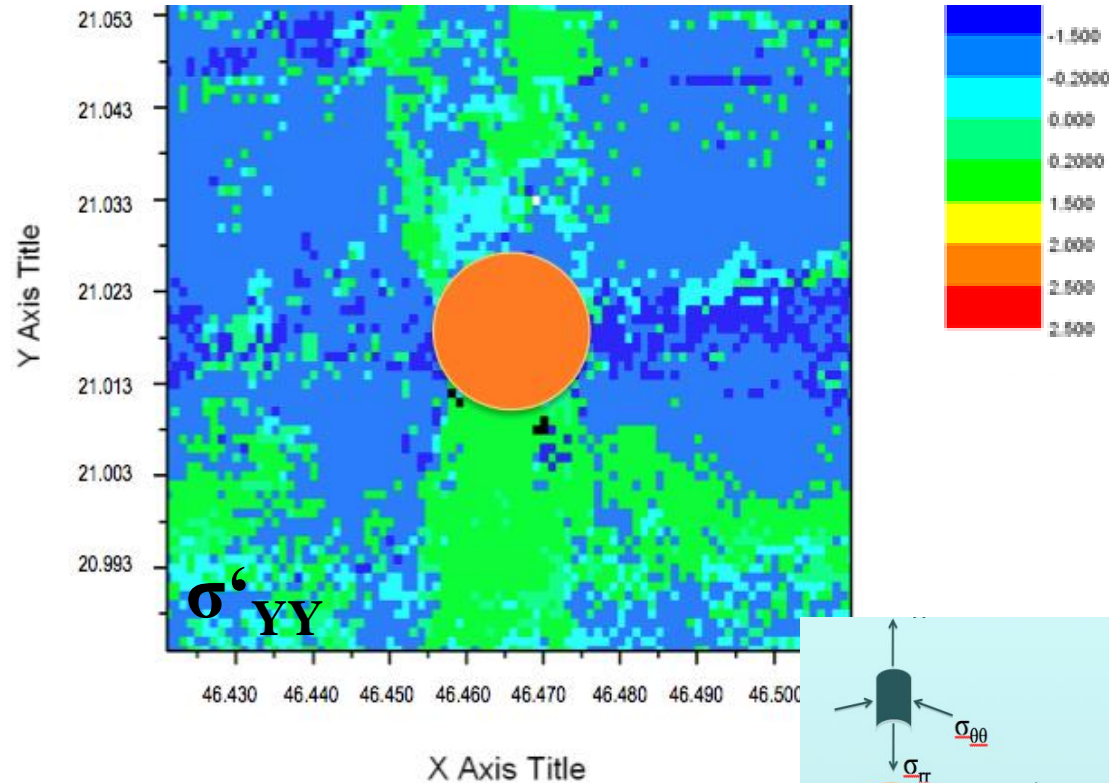
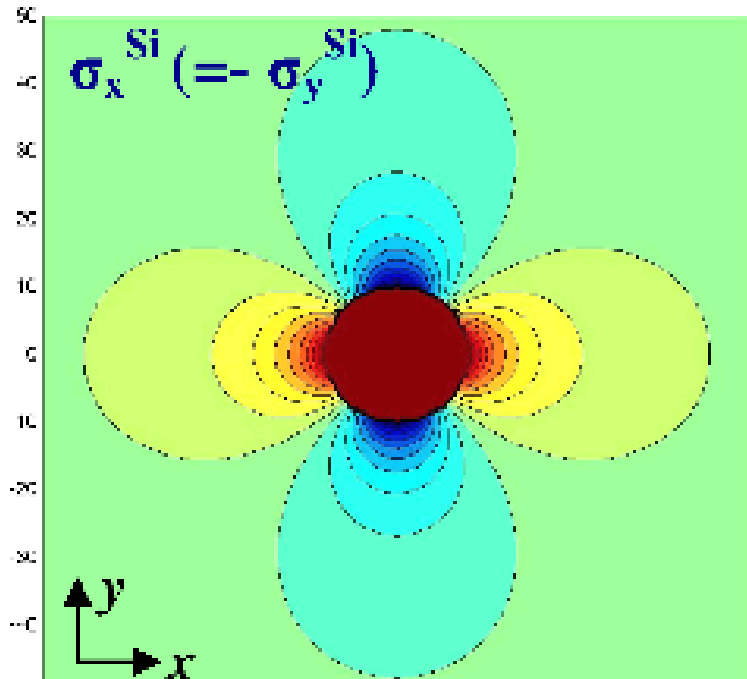
Si Stress State in TSV – *SK Hynix* (Post Annealed)

$$\sigma_{xx} = -\sigma_{yy} = -\frac{R^2 B \Delta \alpha \Delta T (x^2 - y^2)}{2(x^2 + y^2)^2}$$

Lu et al., AIP, 2009;
TSV diam. = 20 μm
Stress Map = 100 μm x 100 μm

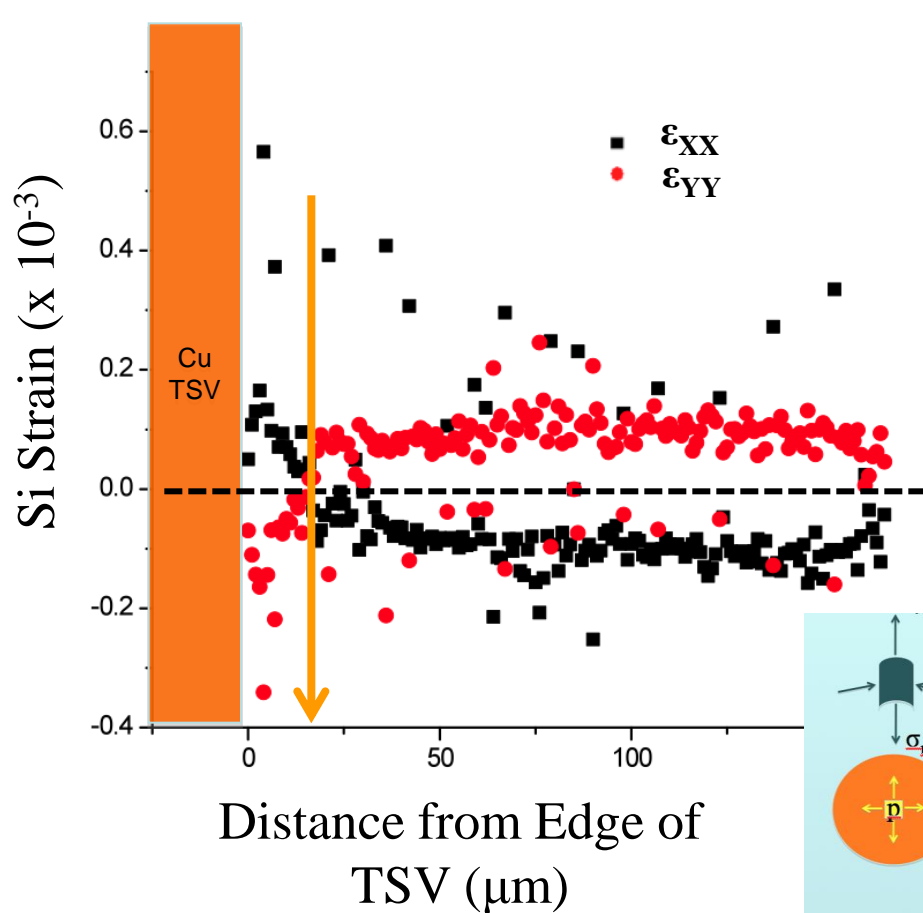
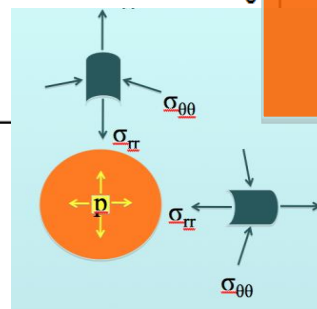
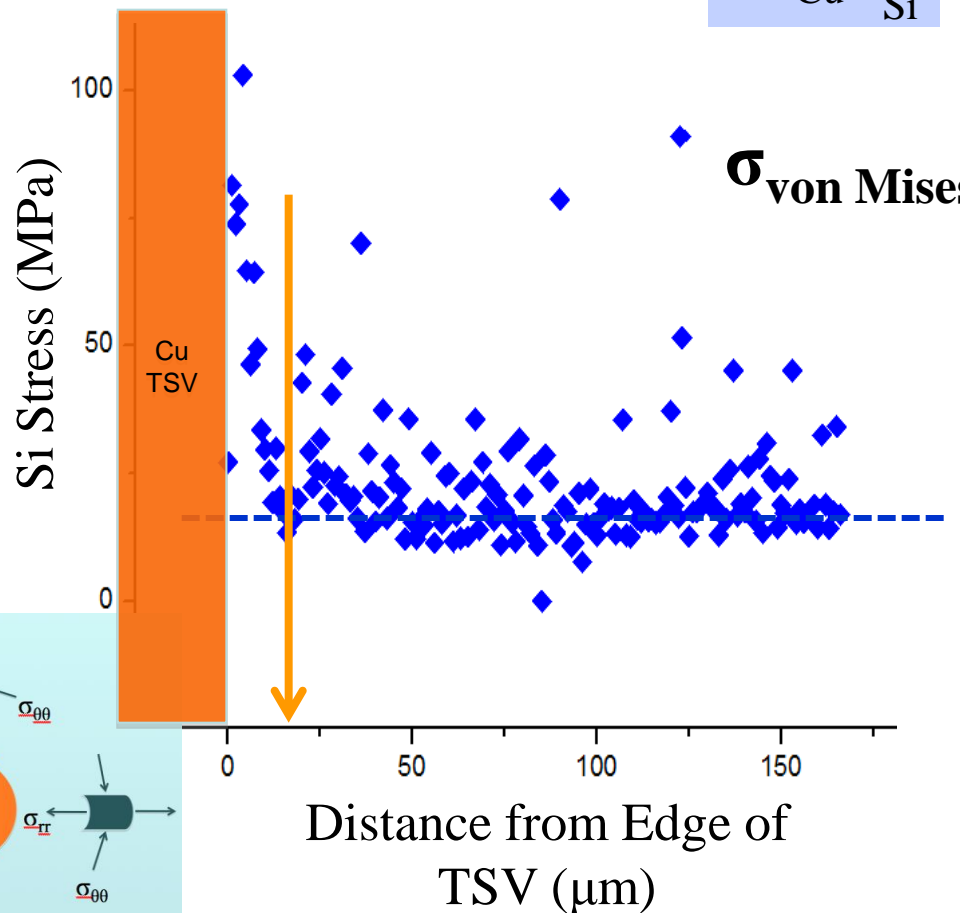
Si Strain Profile from Edge of TSV

- SK Hynix (Post Annealed)

Si Keep-Away Zone:

SK Hynix: 17 μm

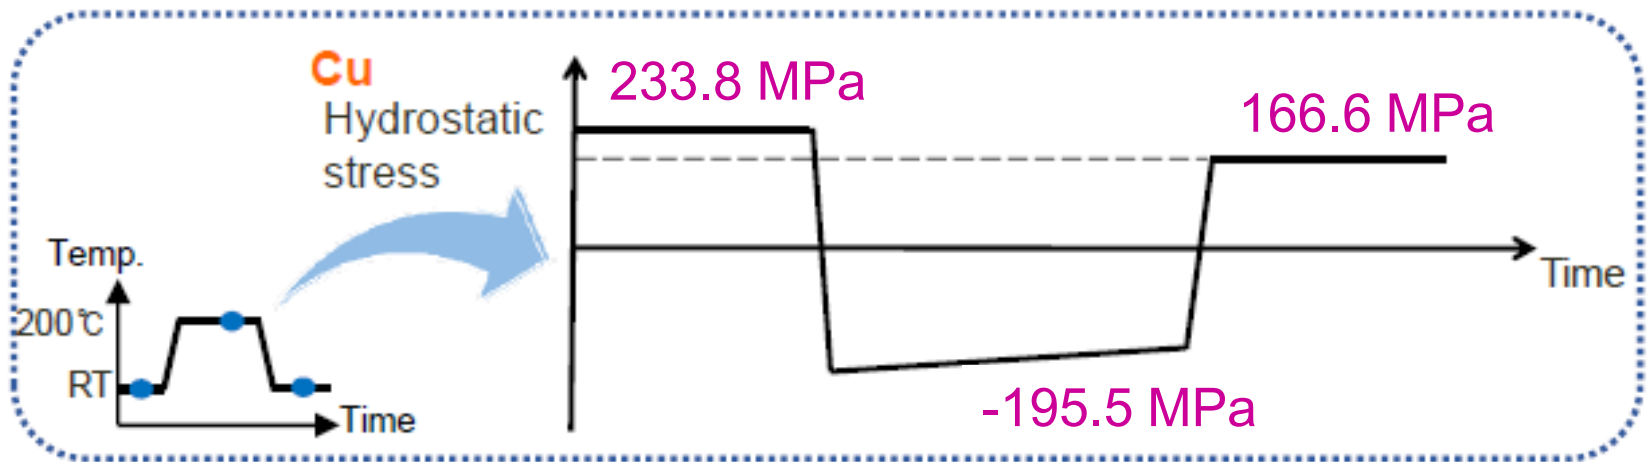
→ Reduce as-received Cu TSV high tensile stress!!

233.8 MPa

-195.5 MPa

166.6 MPa

Electroplating process? Thermal treatment?
Reduce Cu RT grain growth?
