Analysis of high-k HfO_2 and HfSiO_x dielectric films

Charles Evans & Associates/
Evans Analytical Group

Wesley Nieveen
Scientific Fellow
April 16, 2003

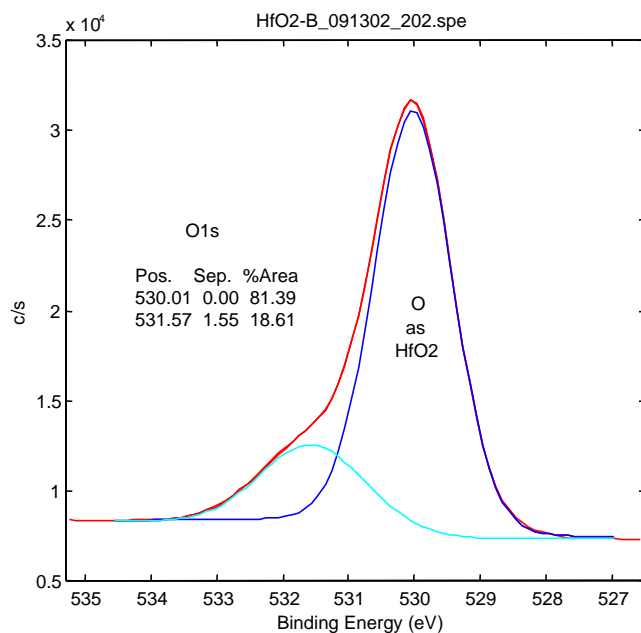
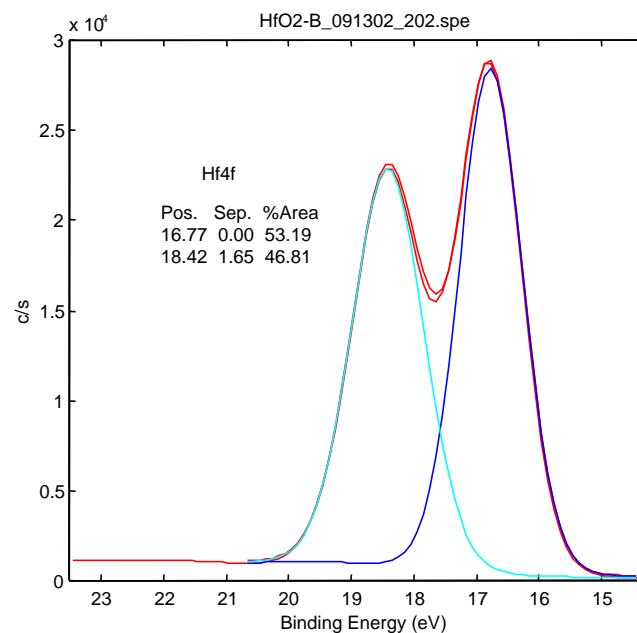
Simple measurement of O and Hf does not give correct O-Hf ratio.

O1s		C1s	Hf4f	Ratio	
63.6		11.7	24.8	Total O:Hf =	2.57 (~Hf ₂ O ₅)
51.6	12.0	11.7	24.8	Corr. O:Hf =	2.09 (~HfO ₂)

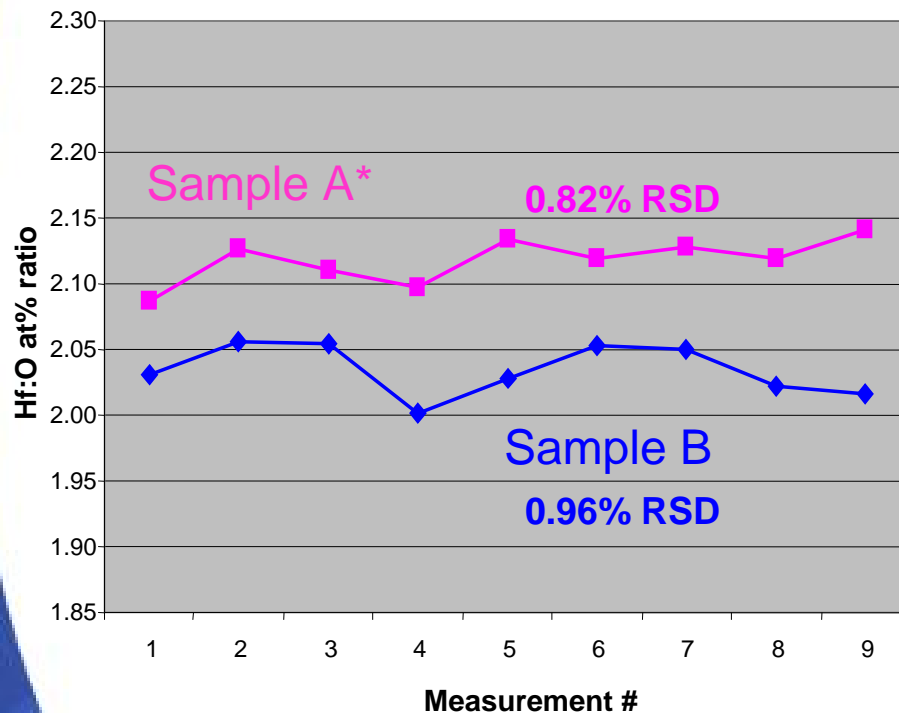
Hf:O corrected repeatability

Hf:O Atom Concentration Ratio: corrected repeatability measurements.

*Sample A contains appreciable Zr

- 10 measurements each
- S/N set for <0.3% precision
- Largest error from O1s curve fit repeatability.
- Data for films >9nm and pure HfO₂.
- Precision decreases with interfacial oxides, silicates, and oxidized impurities.
- IMFP/EAL correction not applied.

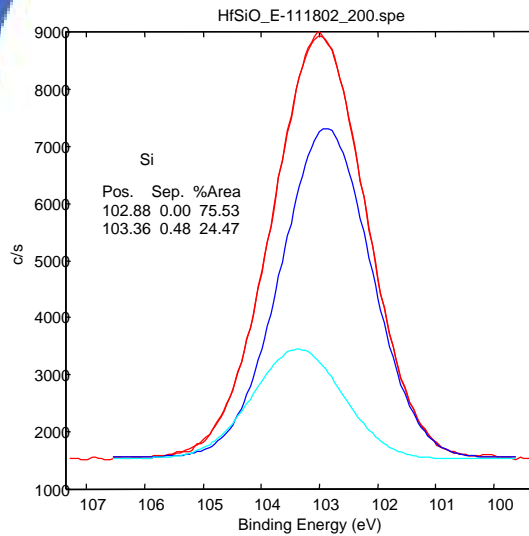
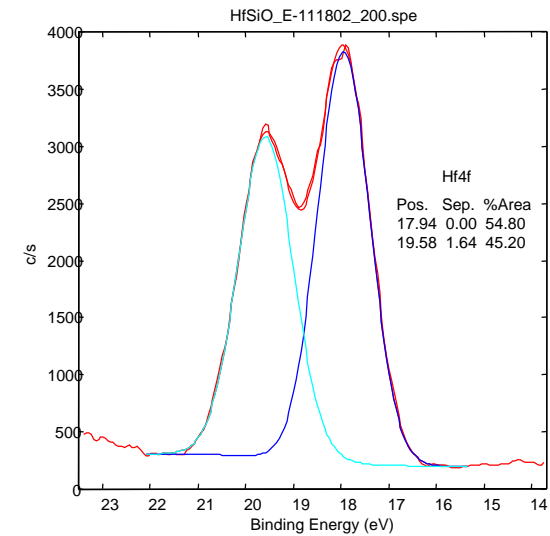
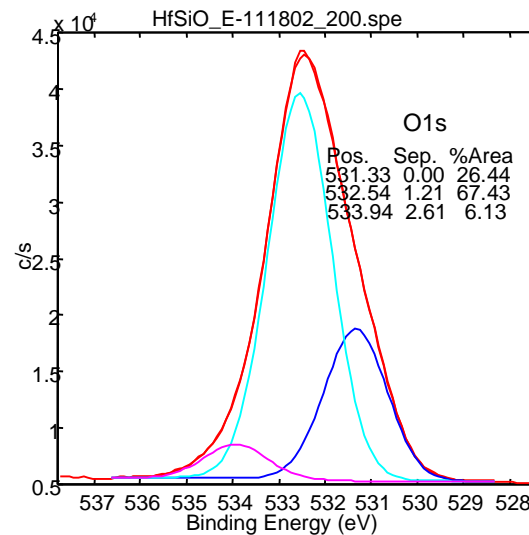
Composition and stoichiometry of HfSi_xO_y films are much more difficult to determine.

n	Atomic %
n	O1s 63.7
n	Si2p 20.8
n	C1s 10.6
n	Hf4f 4.9

- Non-silicate O unclear
- Si suggests either
 1. 2 silicate forms
 2. Silicate + SiO_2
- Hf4f indicates single Hf state

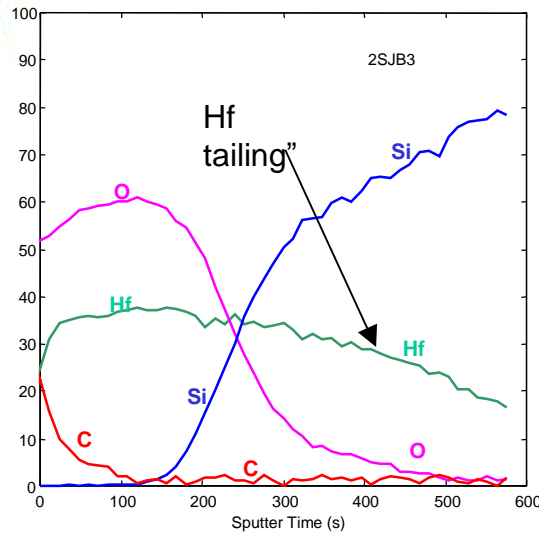
AES profile, 5keV
e⁻ 4 keV Ar⁺

Profiles of ~8.6nm
HfO₂ film on Si
(with interfacial
SiO₂ layer)

All techniques exhibit
severe 'tailing' of the
Hf into the Si substrate.

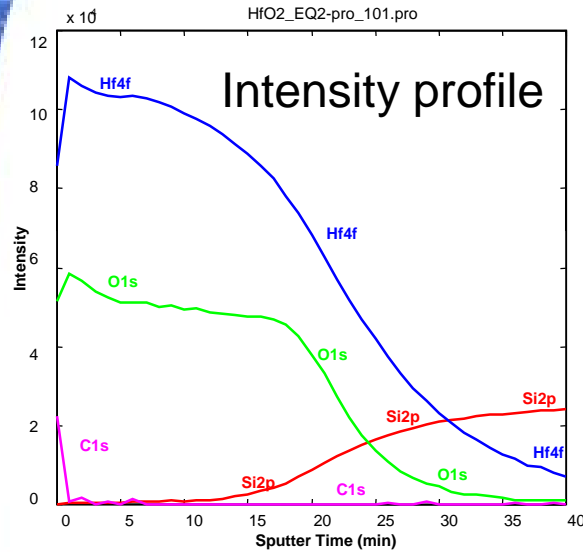
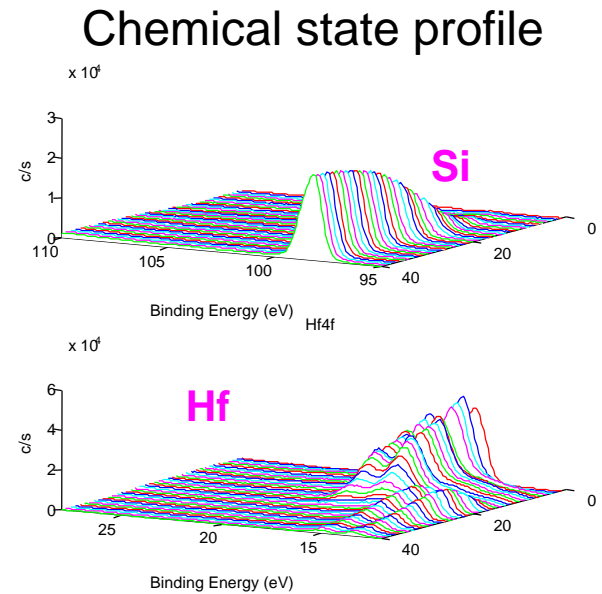
XPS Depth Profiles of HfO₂

Hf metal appears at/near the Si-HfO₂ Interface.

XPS profiles of 86Å HfO₂ clearly show the presence of Hf⁰ in the Si substrate.

B.E. are consistent with HfO₂, Hf⁰, Hf sub-oxides.

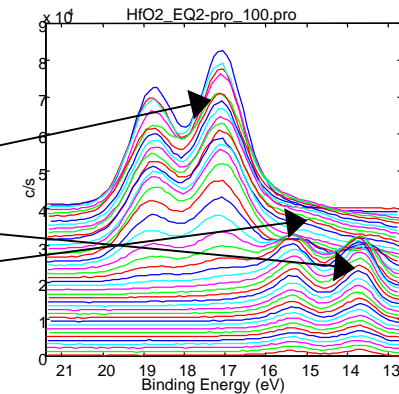
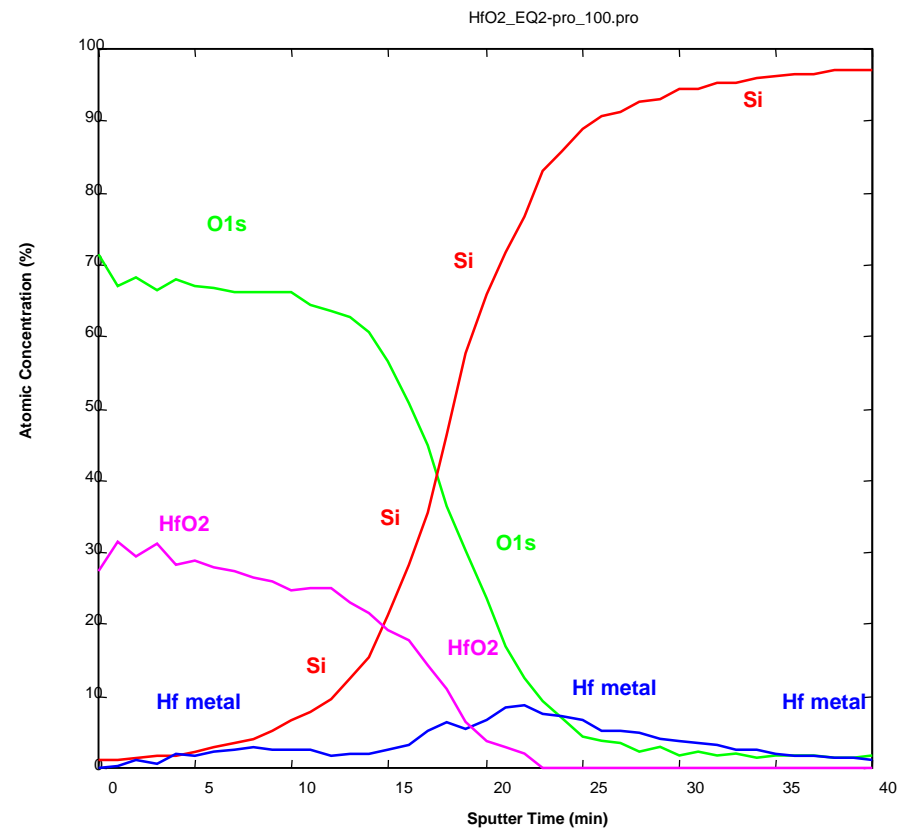
Chemical State XPS Profile of 86Å HfO₂ film on Si.

- n NLLS fit using Hf4f as HfO₂ (@16.3eV) + Hf4f as Hf⁰ (at 13.8eV)
- n Thin interfacial SiO₂ estimated at 5-7Å present (but not shown for clarity)
- n Hf-sub oxides present in HfO₂ film shortly after sputtering starts. Sub-oxide component partially overlaps Hf⁰ component within layer.

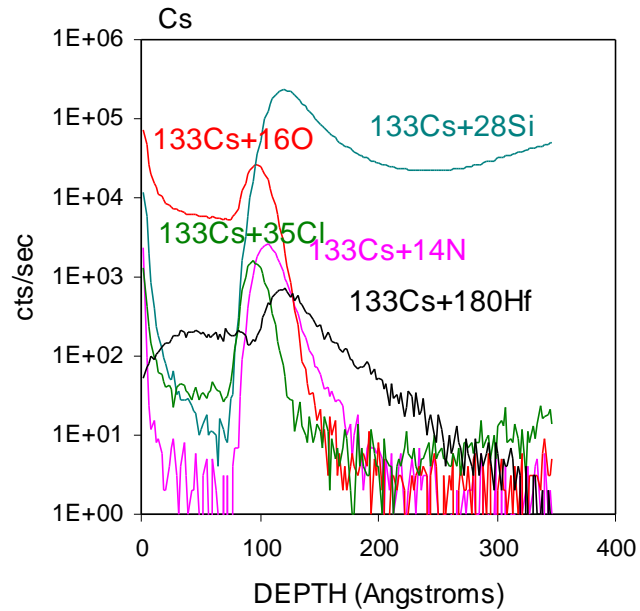
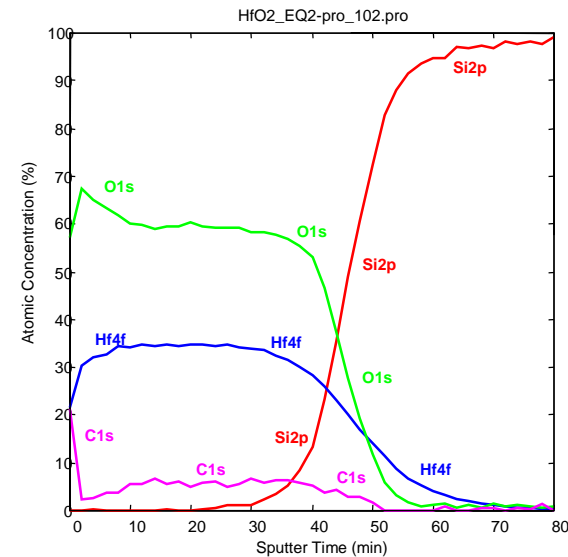
Examples

n SIMS

- CsM⁺ shows strong tail,
- M⁺ has less pronounced tail.
- M+O is self-fulfilling profile

n XPS

- ALD film with high C content
- w/ C, tail extent is reduced (compare to no C).
- Tailing inversely proportional to N doping?

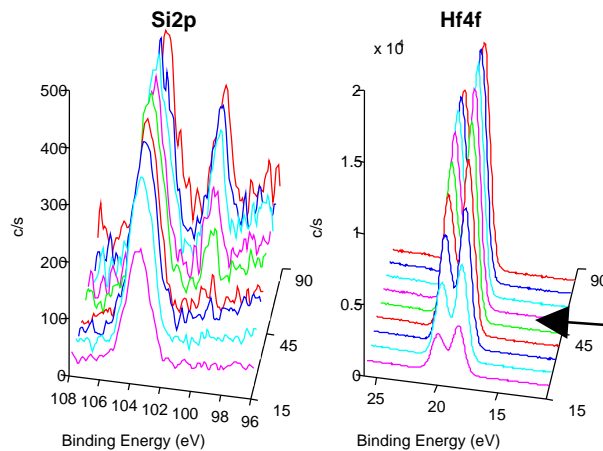
n Angle-resolved XPS of 86Å HfO₂ film, profiled also by XPS, TOF, SIMS.

v No evidence of Hf metal in the Si (or at all).

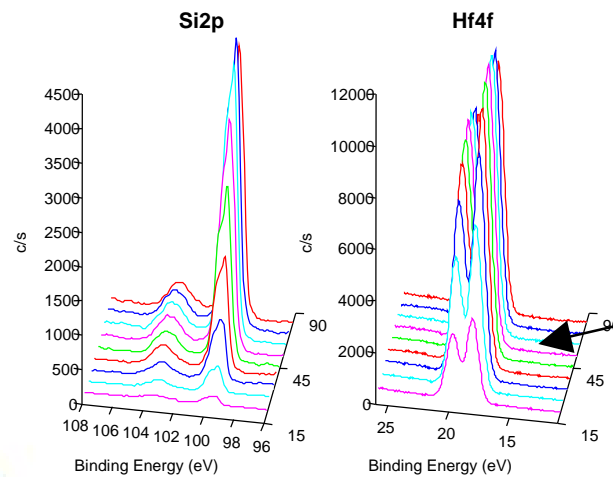
n ARXPS of 40Å HfO₂ layer.

v No evidence of Hf metal present in the sample.

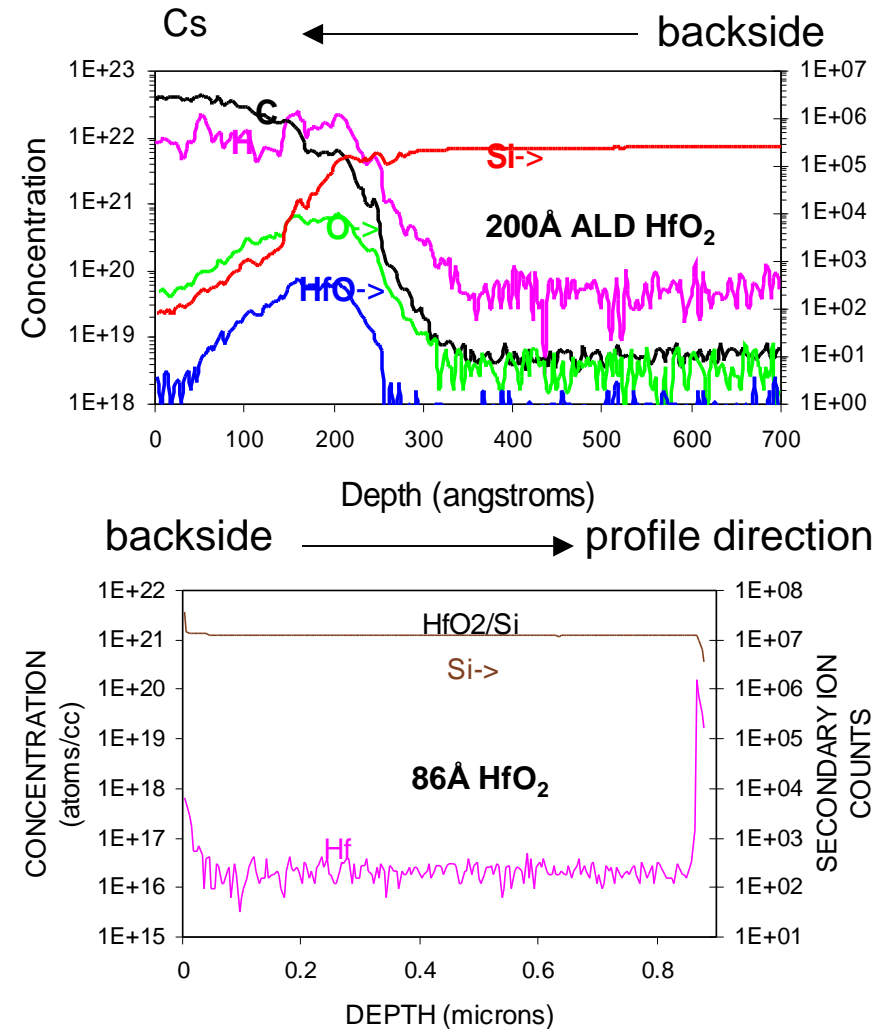
- n Backside SIMS, i.e. a reverse profile from the Si substrate into the HfO_2 film.
- n Requires special sample preparation a'la TEM x-section; thin HfO_2 films on Si are glued face-to-face then backside thinned.

∅ **Backside SIMS shows no Hf in the Si substrate!!**

n Backside SIMS was employed to verify the presence of Hf within the Si substrate. In this method, a substantial amount of the Si substrate is removed from the back of a sample, and a SIMS profile is acquired from this thinned backside through the remainder of the Si substrate, through the Hf oxide film. This profile clearly shows that the Hf does not exist within the Si at the depths suggested by AES, XPS, or standard 'frontside' SIMS.

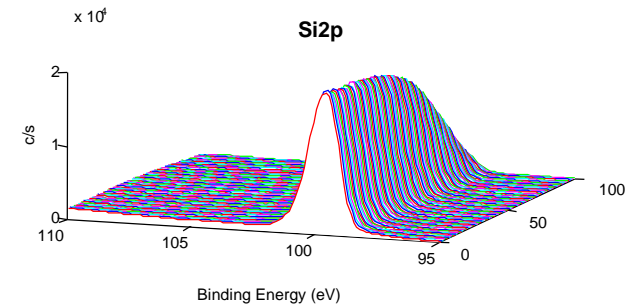
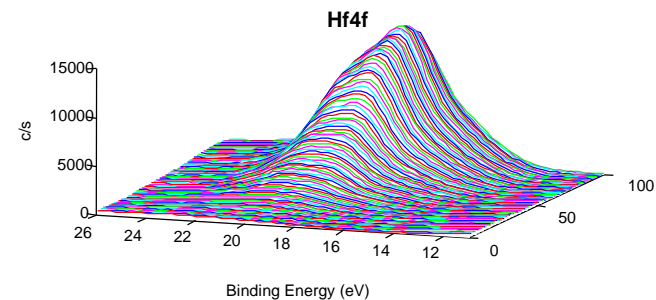
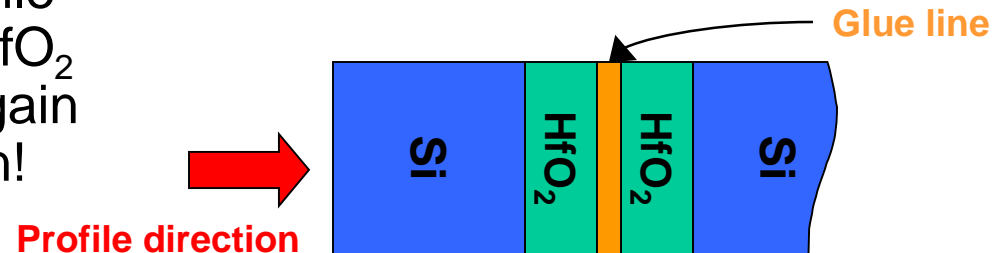
- n *Coup de grace* is XPS backside profile of HfO₂ film.
- n No Hf metal is observed in the Si substrate.
 - Note however, that due to DOI (IMFP, EAL), Hf as HfO₂ begins to appear within Si region.
- n Continuation of profile through glue line, HfO₂ layer, and into Si again shows Hf⁰ formation!

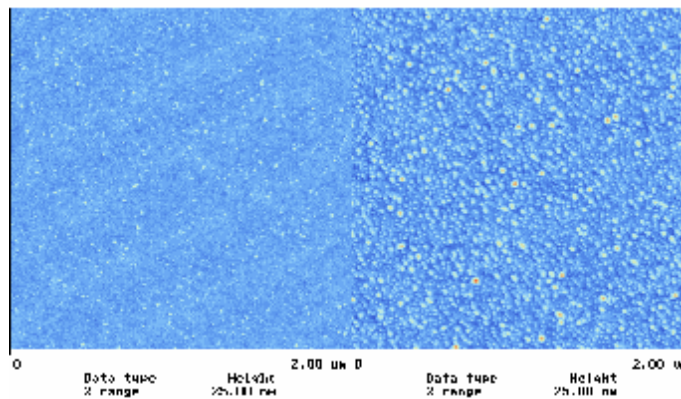
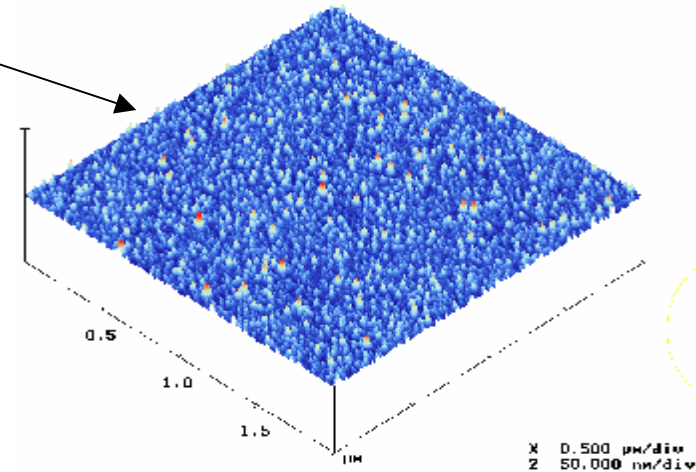
Top of sample Bottom of crater.

$$R_a = 0.53\text{nm}$$

$$R_a = 2.52\text{nm}$$

- Roughening by the ion sputter process does not account for the long depth of penetration by the Hf into the Si. (see also Sematech AVS presentation).
- Large mass difference between Hf and Si plus large differential sputtering, knock-on, localized heating, etc. may result in Hf 'dissolving' into Si. Analogous to Au on Si profiles.

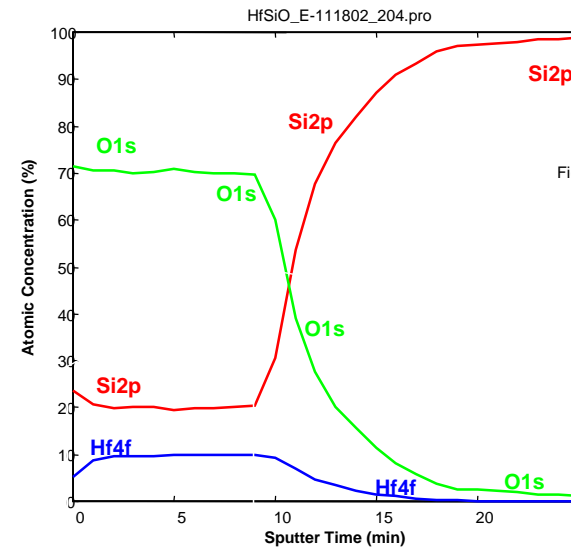
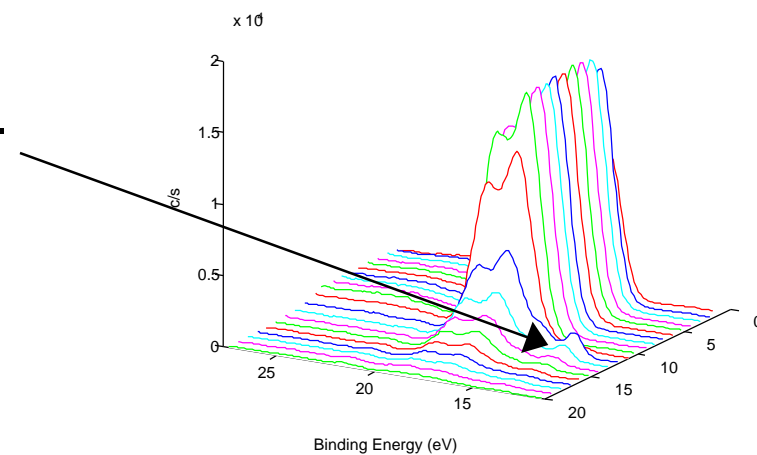
- n Profiles of thin hafnium silicate layers behave differently than HfO₂
- n Behavior depends on Hf-to-Si ratio
- n Regardless of Hf:Si ratio, at interface, Hf metal is seen but tail extent is usually small. (compare to HfO₂ profile).

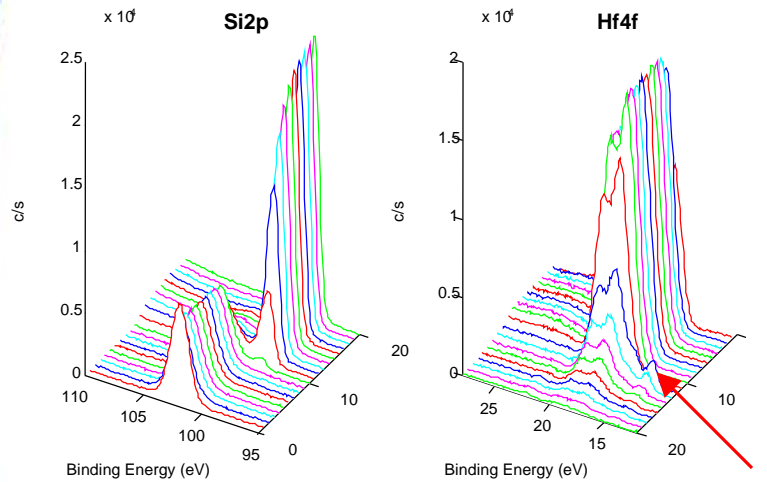
Hf:Si \approx 1:2

n At Hf:Si <1:

- Hf remains as HfSiO₄ through the film.
- **Hf forms Hf⁰ at interface but tailing is usually short.**
- Si as silicate (102.5eV) is ~const. through film.

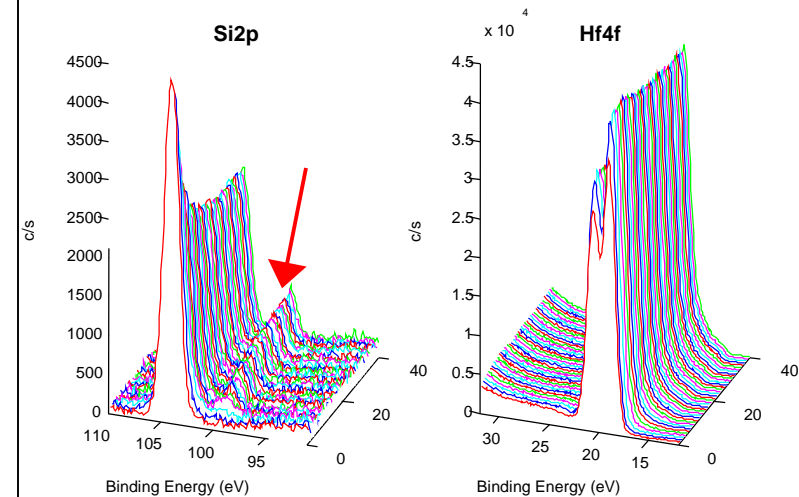
Hf:Si \approx 2:1

n At Hf:Si >1 (?):

- Hf remains as HfSiO₄ through the film w/ small sub-oxide.
- **Shortly after sputter, Si shows silicate/oxide + Si⁰!!**
- **Hf scavenges O from Si to maintain HfSiO₄!!!**

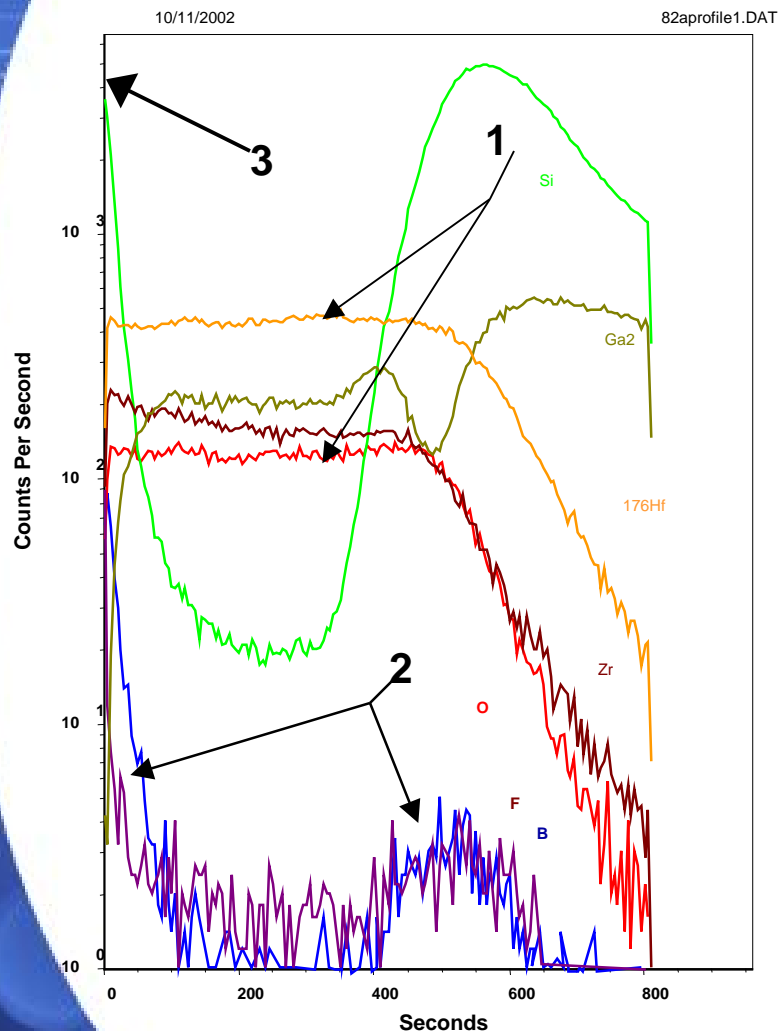
- n Nominal 86Å HfO₂/Si film (by MOCVD?).
- n Test of TOF for profiling composition:
 1. Hf and O are flat through the layer – minimal matrix problems - maybe.
 2. TOF shows a surface and interfacial F layer + high Zr impurity.
 3. (anomalously high) TOF suggests that there is a high surface Si concentration.
 4. Acquisition conditions not optimized?

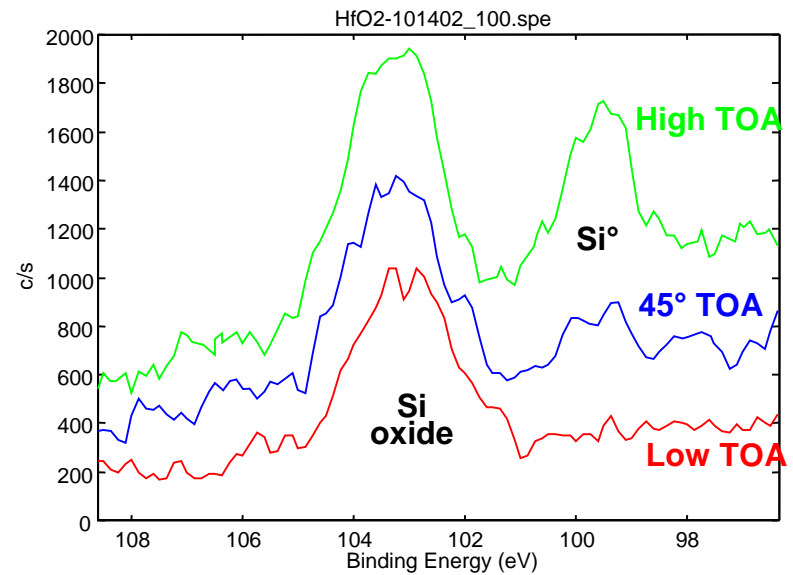
XPS shows Zr and F.
ARXPS confirms surface
and interface F layer.

XPS composition shows much lower surface Si than expected from TOF.
