Improved Embedded Alumina Defect Performance through a Multi Particle Slurry for Hard Disk Polishing

Cabot Microelectronics Hard Disk Drive Slurry Development Division – Singapore

15th September 2010

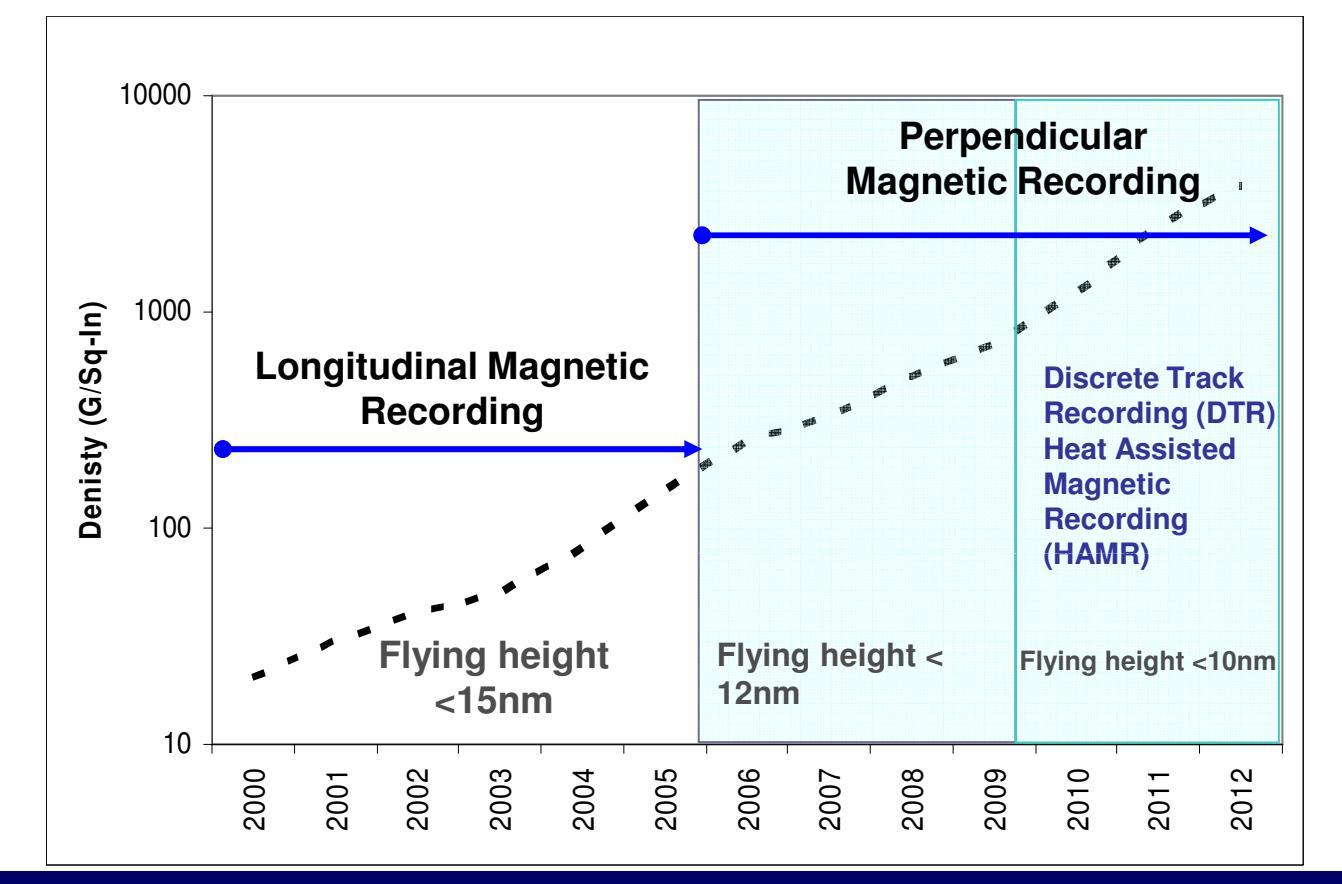
HDD Industry Technology Road map

Higher field densities are desired by HDD technology road map

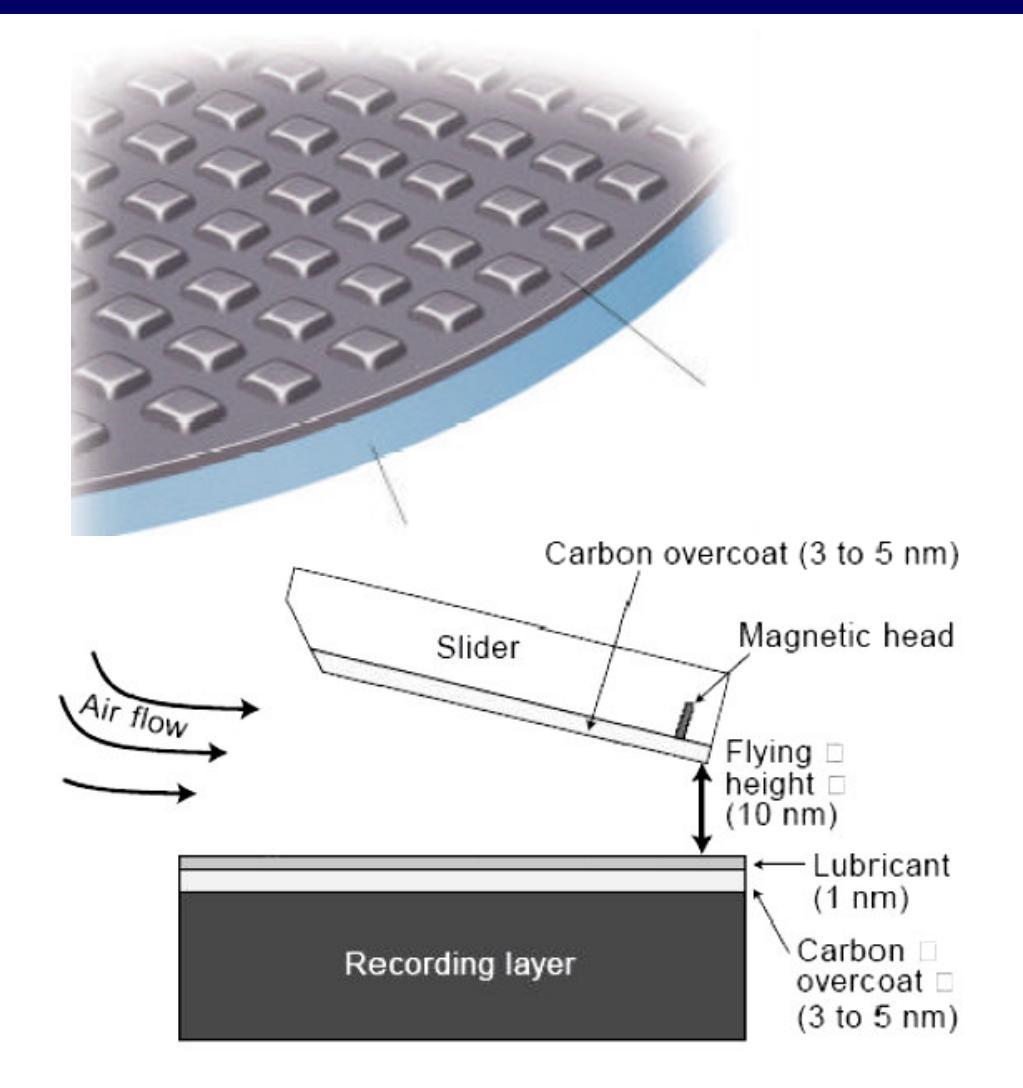
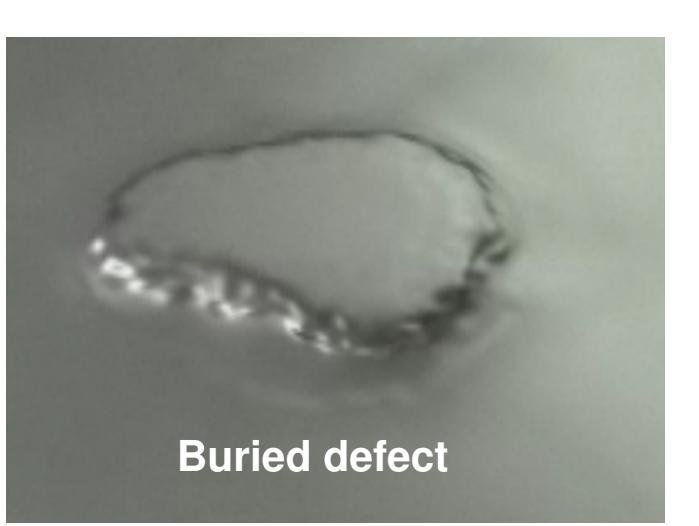
Embedded Alumina Defect Challenges

- 1. Low S/N ratios
- 2. Obstruct slider motion above substrate surface
- 3. Distortion in magnetic field in defect region

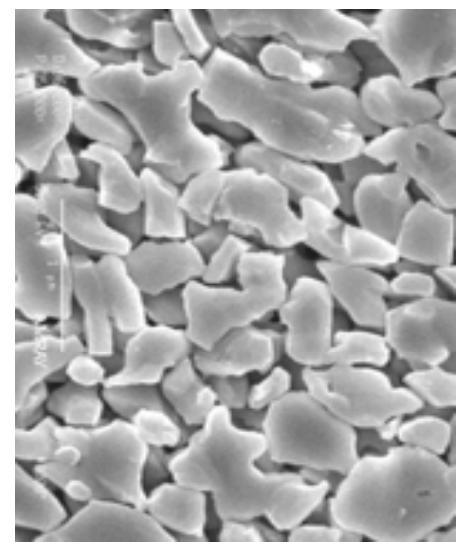
- 1st step slurry in HDD substrate polishing is the only alumina source to cause embedded alumina defects
- Embedded alumina is seen either at post 2nd step defect review or at device failure
- Sharp edges of alumina gets embedded into Ni-P layer, leaving fractured particle(s) inside surface film
- Particles still resides in film after P2 polish
- Subsequent process steps magnifies the presence of the embedded particle
- Methods such as FIB, FESEM, and SEM EDX reveal the defect type to be Al_2O_3

Irregular shape alumina in slurry

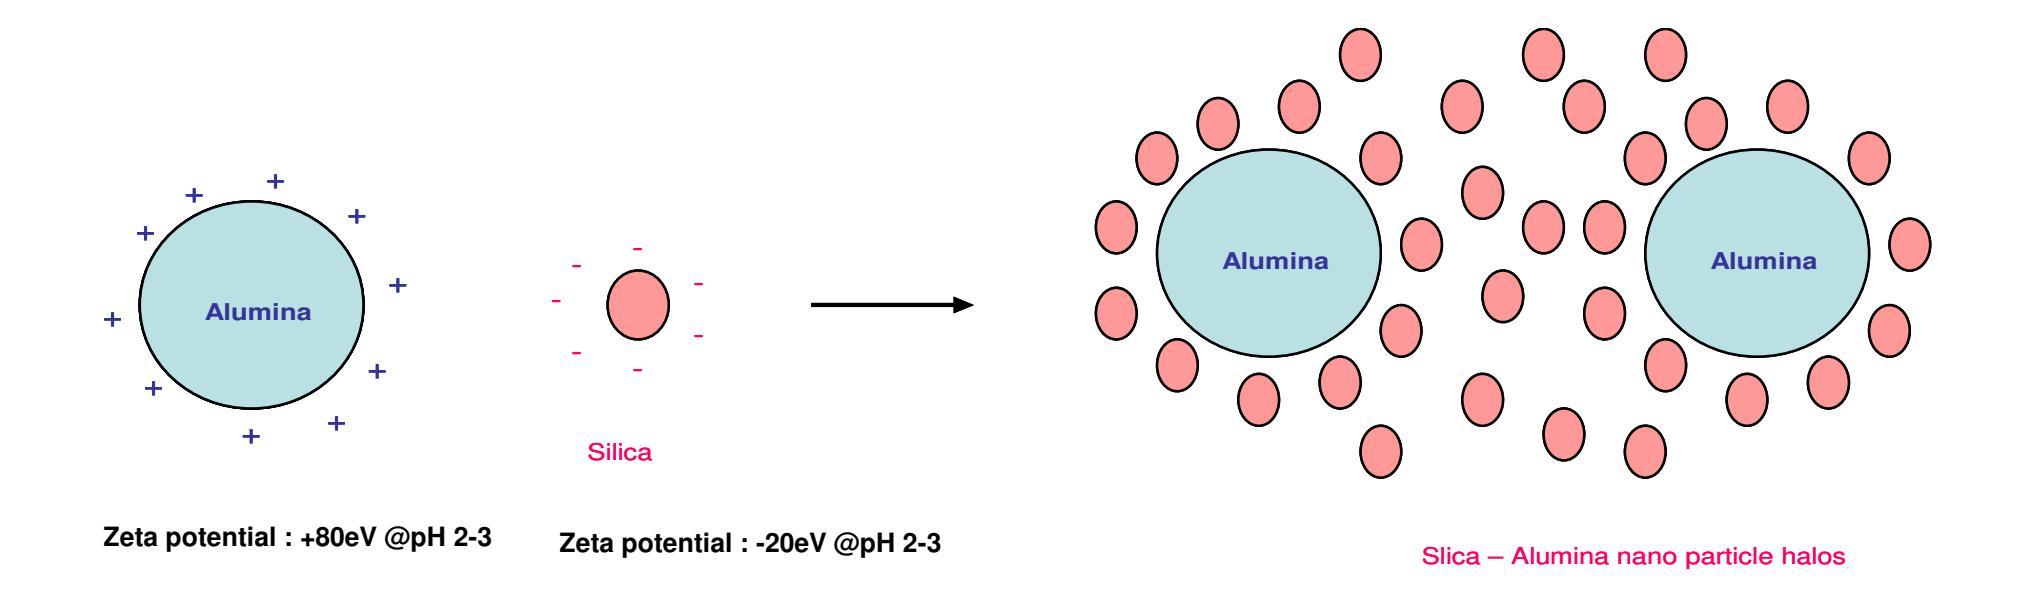
Alumina-Silica Interaction Mechanism

• Electrostatic attraction between alumina and silica particles leads silica to coat around alumina

Due to opposite surface charges on alumina and silica, silica particles get coated around alumina in slurry media

Silica particle coating around alumina makes the substrate - particle interaction less sever to prevent embedded alumina defects

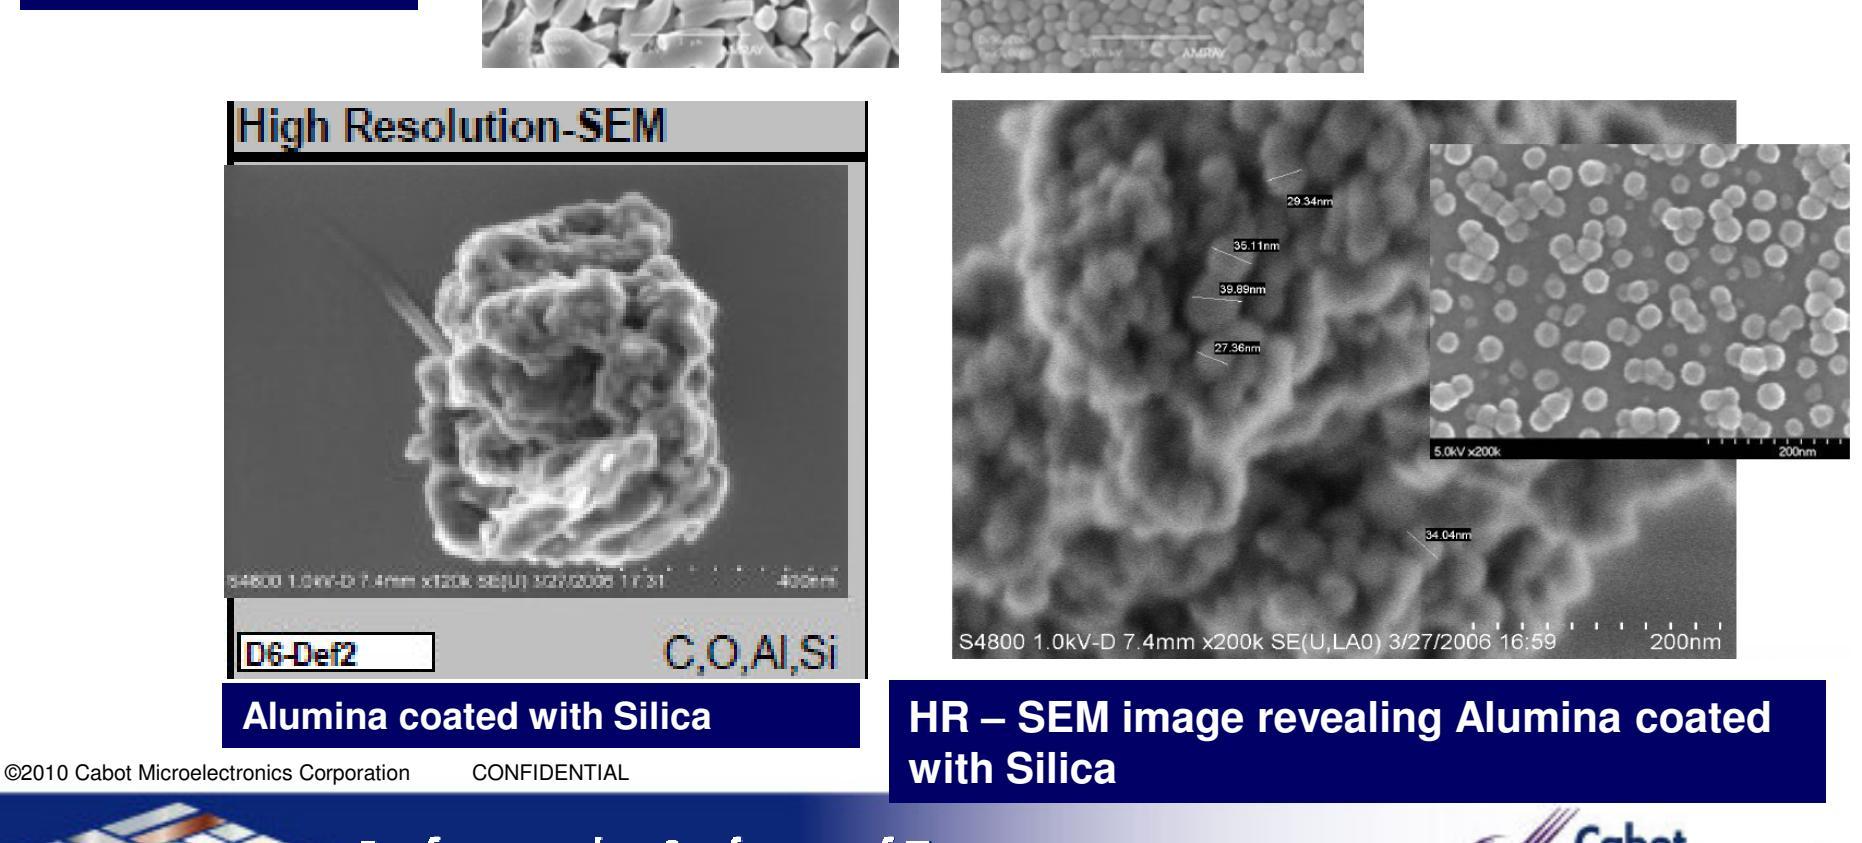
Solution for Embedded Alumina

US Patent 6.896,591 B2

Irregular shape alumina 0.1um – 0.9um

Regular shape

0.05um – 0.4um

alumina

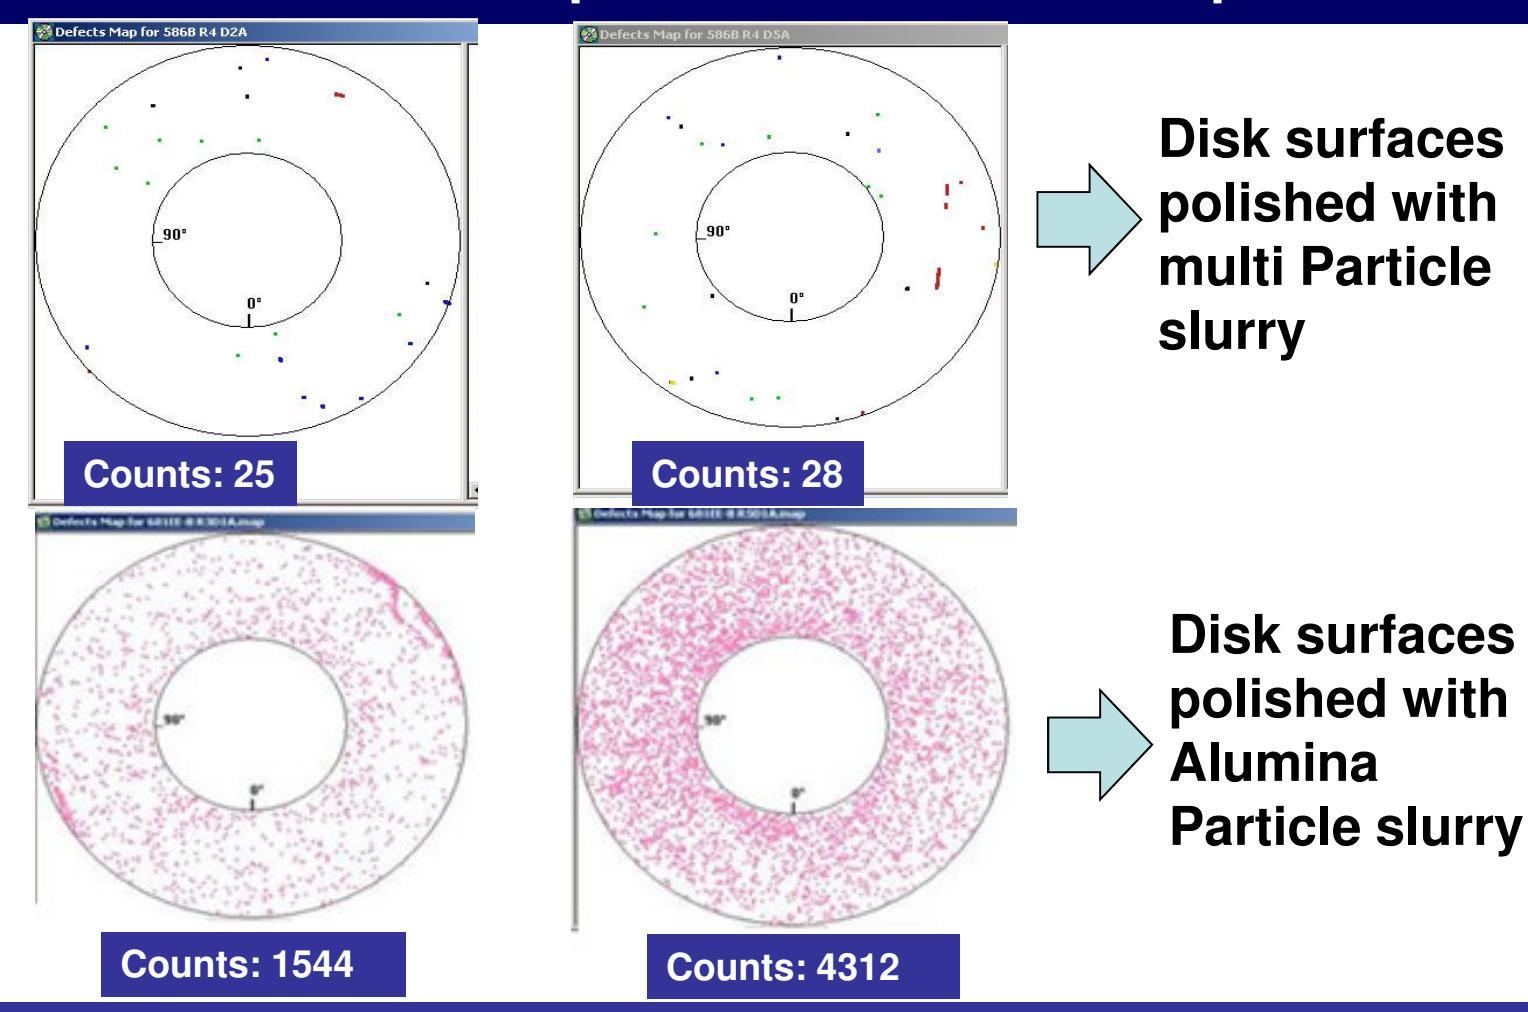
Candela Defect Maps after 2nd Step Polish

• Pure alumina 1st step slurry polish disks give higher particles on disk surface. Defects maps were taken after P2 polish process.
